## Gaylord Rockies Resort & Convention Center

### Tree Preservation Report Update

Ryman Hospitality Properties, Inc.  
6700 N Gaylord Blvd  
Aurora, CO 80019

Austin Edwards  
Consulting Arborist  
ISA Board Certified Master Arborist #RM-8272B  
ISA Tree Risk Assessment Qualified  
CO Qualified Supervisor #37270

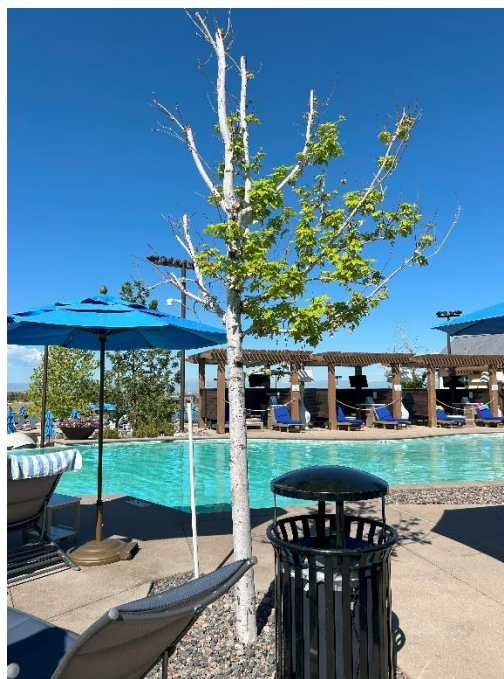
**Photo 1.** Red maple #1243 in the pool area was in poor condition and recommended for removal.
