2252 TOWER ROAD TREE REPORT

AUGUST 22, 2022

CJG Transport LLC
2252 Tower Road
Aurora, CO 80011
Gadi Ogbogu
512-554-4323
o_gadis@yahoo.com

Robert Brudenell

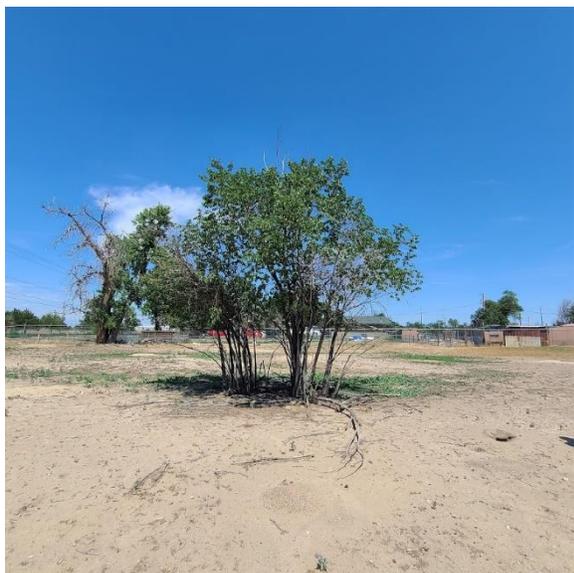
Tree 1: The west central, southern portion of the site had a group of American Elm (*Ulmus americana*) trees on it. Only one tree was larger than four inches. The one tree measured five (5) inches in diameter at breast height (DBH) and was not in good condition. This grouping of trees including the five-inch diameter tree will be removed during construction. The leaves were sparse, tips and interior branches were dead, and a large wound extended most of the trunk length.

Condition ratings were based on canopy dieback, trunk wounds, structural and foliar impacts of insects and disease, defects in trunk/basal flare, lead size and density. The American Elm (tree 1) was the largest volunteer growing in small grove of volunteers, there was a large decay pocket in the trunk that extended for most of the trunk. There was dieback on the branches, significant interior deadwood, and foliage was sparse. This tree was given a condition rating of 30%. The Siberian Elm (tree 2) located in the upper portion of the property on the western side was more than half dead, poor structure, large wound on the trunk, poor basal flare, and in overall poor condition, additionally it is an invasive species, and given a rating of 20%. The Siberian Elm (tree 3) was growing along the property line in the Northwestern portion of the lot had significant deadwood, girdling roots on one side of the trunk, and a large wound on the trunk, it is an invasive species; this tree received a condition rating of 20%.

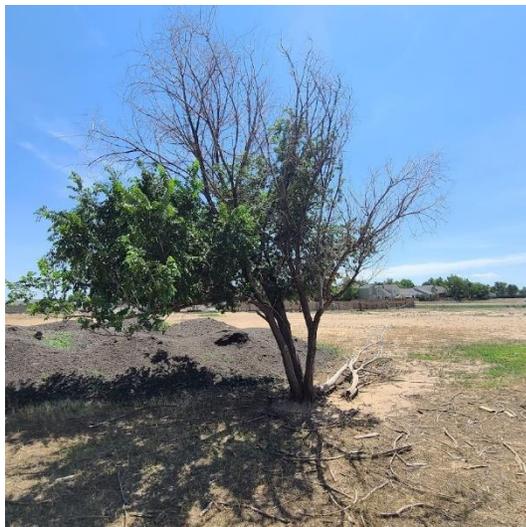
Tree 2: Another grouping of Siberian Elm (*Ulmus pumila*) trees was located in the northwest of the north portion of the property. This group consisted of 3 trees, two of which were dead. The partially live tree was 8.5 inches in diameter DBH, had a poor basal flare, and was mostly dead. This grouping of trees will be removed.

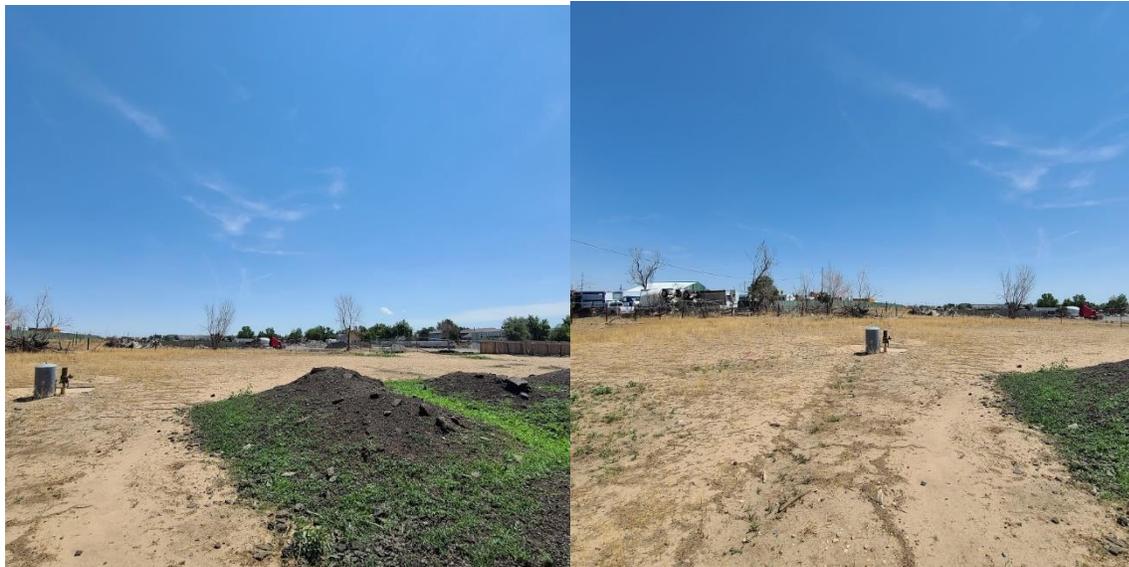
There were multiple groupings of trees along the north and east sides of the property, most of those trees were dead. The few live trees consisted of small volunteer Sumac sp. and Siberian Elm trees less than 4 inches DBH.

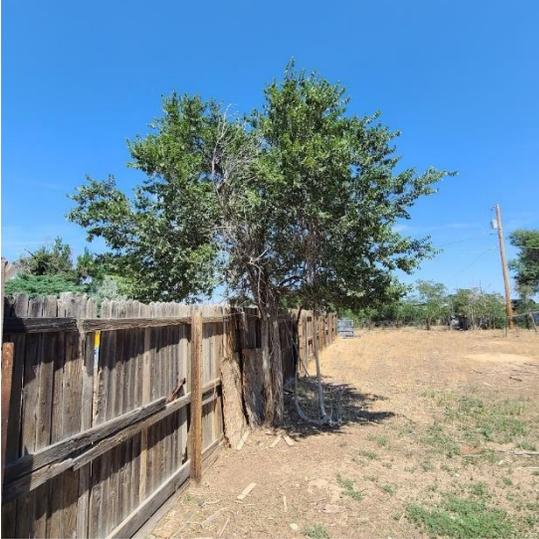
Tree 3: Another small grouping of Siberian Elm (*Ulmus pumila*) trees was located along the property line on the west north side of the property in the north portion of the lot. Several of the stems were dead and one stem measured larger than 4 inches DBH, that stem measured 7.75 inches DBH. There was a large wound extending the length of the trunk, with a poor basal flare and girdling roots. This grouping of trees will be removed.

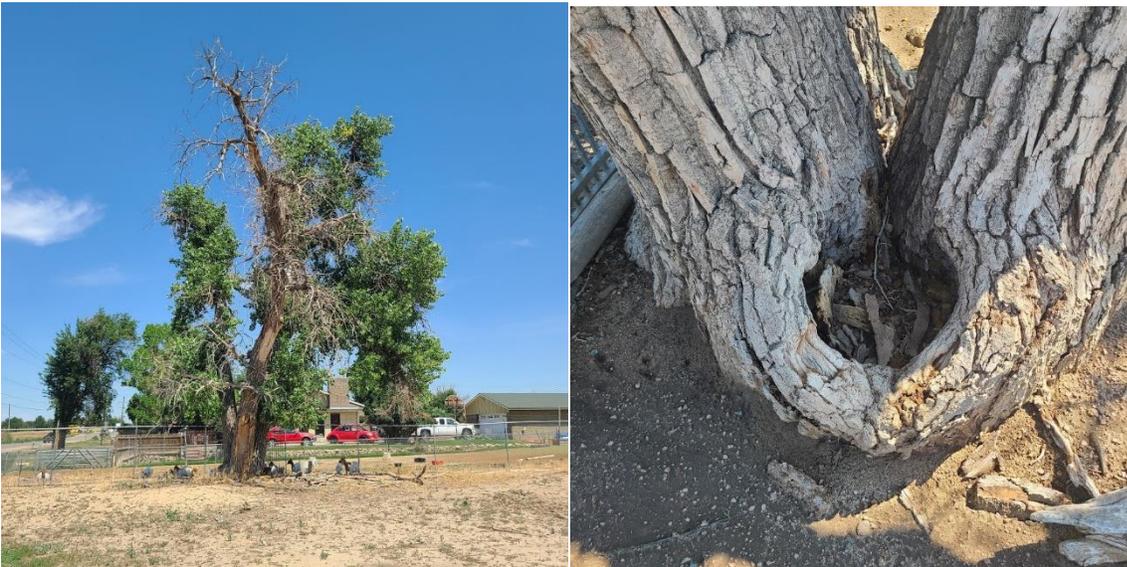
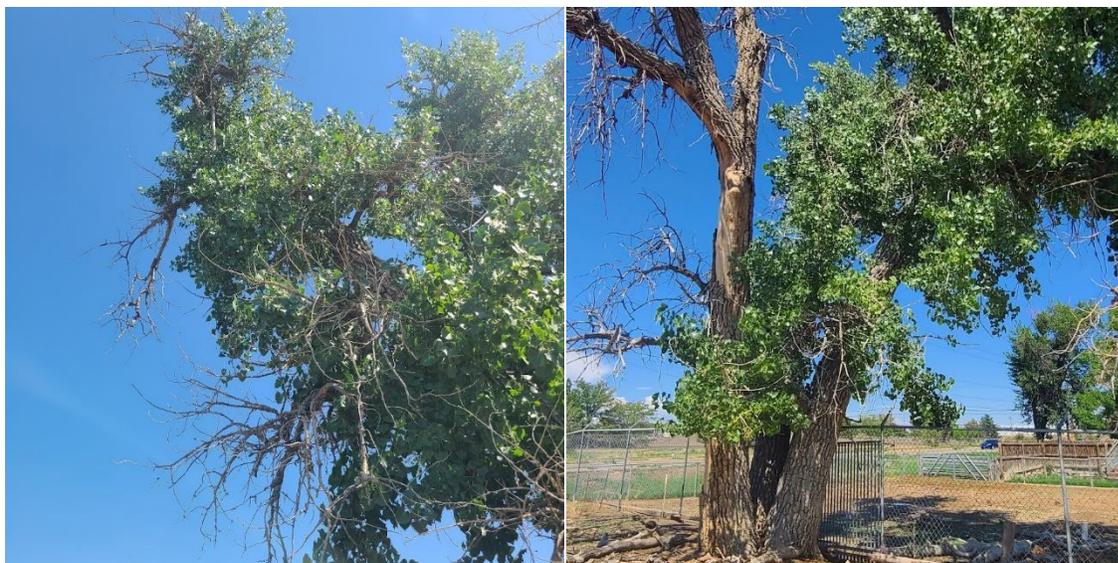
Tree 4: A large three stemmed Cottonwood (*Populus deltoides*) tree was growing along the northwest southern portion of the property. One stem was dead. The other stems measured 30.25 and 29.5 inches DBH. The Cottonwood has significant dieback all throughout the canopy, there is a large decay pocket at the base where the three stems converge. The remaining two live stems are leaning significantly away from the decay pocket and towards the neighboring property. One of the stems has an old lightning strike with extensive decay and is hollowed out from animals and birds. Although this tree was originally planned to remain and does not need to be removed based on the site plan, the tree has significant structural, decay, and is in very poor condition and overall health and it is recommended to remove this tree to eliminate the current hazardous situation which will increase

The one large tree on the site is a Cottonwood tree, this tree is in irreversible decline and has significant structural issues and was deemed a hazardous tree and recommended for removal to protect the neighboring property as well as people and property on this site during development and post development as this tree is expected to further decline and increase in it's hazardous conditions. As a hazard tree this tree does not meet the requirement of The City of Aurora's Tree protection and mitigation plan.

There are currently four trees on the site at 2252 Tower Road in Aurora, CO that required an appraisal based on size, however the Cottonwood was determined to be a hazard tree and therefore was not appraised as hazard trees are not appraised. The Cottonwood tree is recommended to be removed to eliminate the threat of damage to the neighboring property and livestock kept there as well as to any people or property on 2252 Tower Road during and post development. The Cottonwood has a large decay pocket at the base of three stems with included bark and poor stem attachment. One stem is completely dead and the other two stems are leaning at a significant angle and are in irreversible decline with dieback leading to large branch drop. The stems are leaning toward the neighboring property to the north where livestock are kept and a septic field is present, in addition to fencing. One of the stems has noticeable internal decay. Both live stems are dying back on almost all branches and dropping branches. This tree is currently a hazard tree and with future development adding additional targets within a potential failure zone, it will increase the hazard. This tree does not have a future path of recovery and is expected to decline further, again increasing hazardous conditions.
