TREE APPRAISAL AND MITIGATION REPORT

BROTHERS REDEVELOPMENT, INC

CHAMBERS COMMUNITY

May 16, 2024

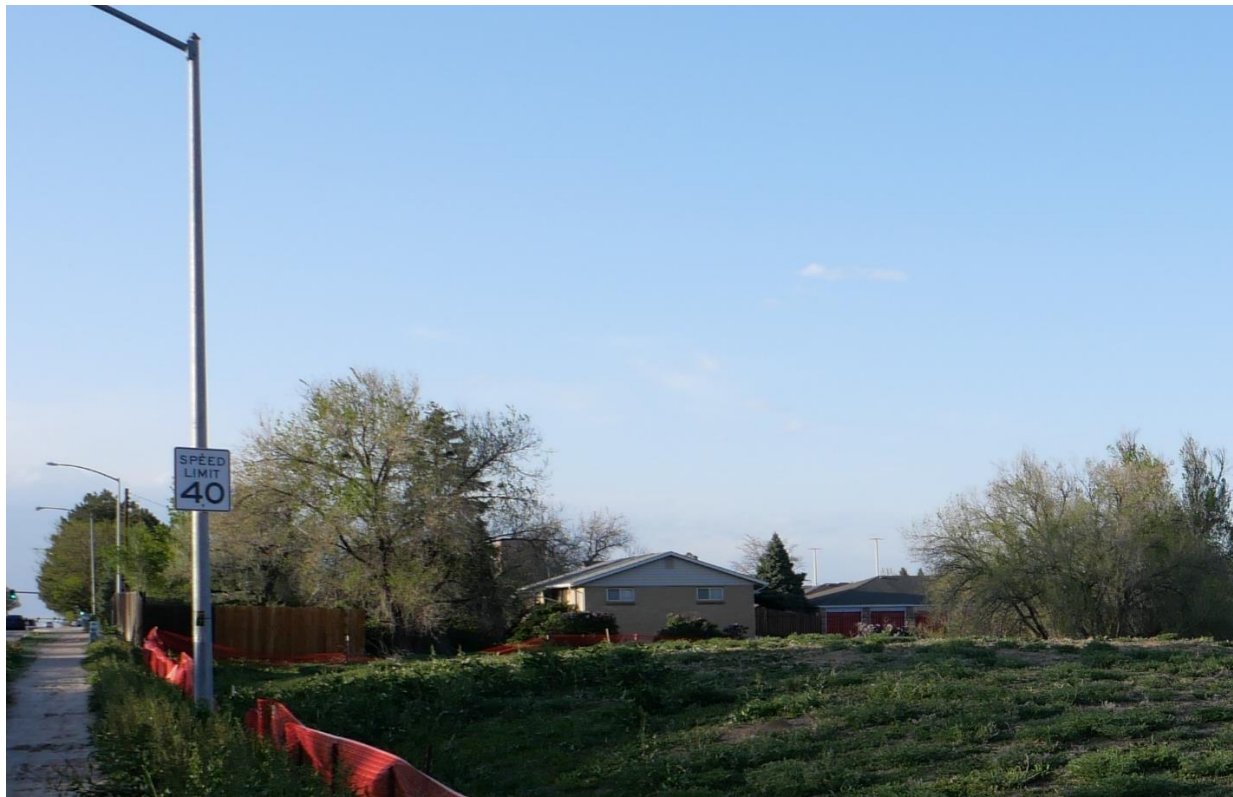
Photograph 1.

One Siberian elm (*Ulmus pumila*) was found along Chambers Road and adjacent to 1812 South Chambers Road (Marsha Moss property). The tree is in fair condition and has an equivalent trunk diameter measurement of 21.1 inches (multi-stem tree).

This is looking north along Chambers Road. Photograph of Siberian elm number 1 on the left and number 2 on the right.

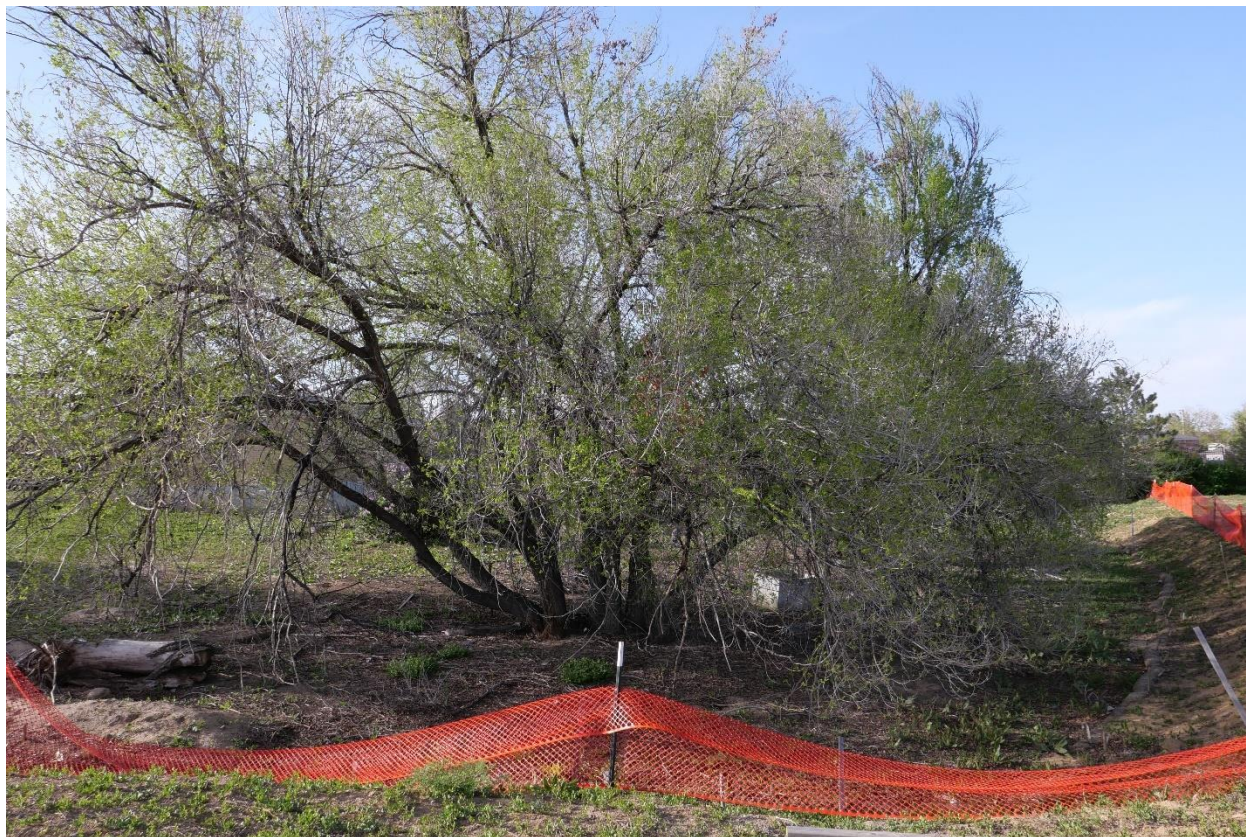
Photograph 2.

Four Siberian elms remain on the south and east sides of the Moss property that abut the subject parcel. It should be noted that there is a 15-foot buffer shown on Block 1 Site Plan Amendment 09-2021. Considering this buffer there should be minimal to no additional impacts to the Siberian elms from construction. These trees are all multi-stem elms, and some have formed small groves consisting of multiple stems (trunks). These elms are all in fair condition and with estimated equivalent trunk sizes 33.0, 12.0, 24.0, and 16.0 inches. I did not enter the Moss property to inspect or measure the trees.

This is a photograph of Siberian elm number 2 and looking along the property boundary between Moss and the subject property. In this photograph, Moss is inside the orange fencing where the tree is.

We recommend no appraisal or mitigation inch requirements for the subject property. Care should be taken to preserve the trees on the abutting Marsha Moss property. It is very unlikely that the trees at Cube Smart Self Storage will be impacted by construction activities. Also, recommending no appraisal for Siberian elms numbers 8, 9, or 10. No recommendation for any trees existing in the Woodrim Tributary parcel.

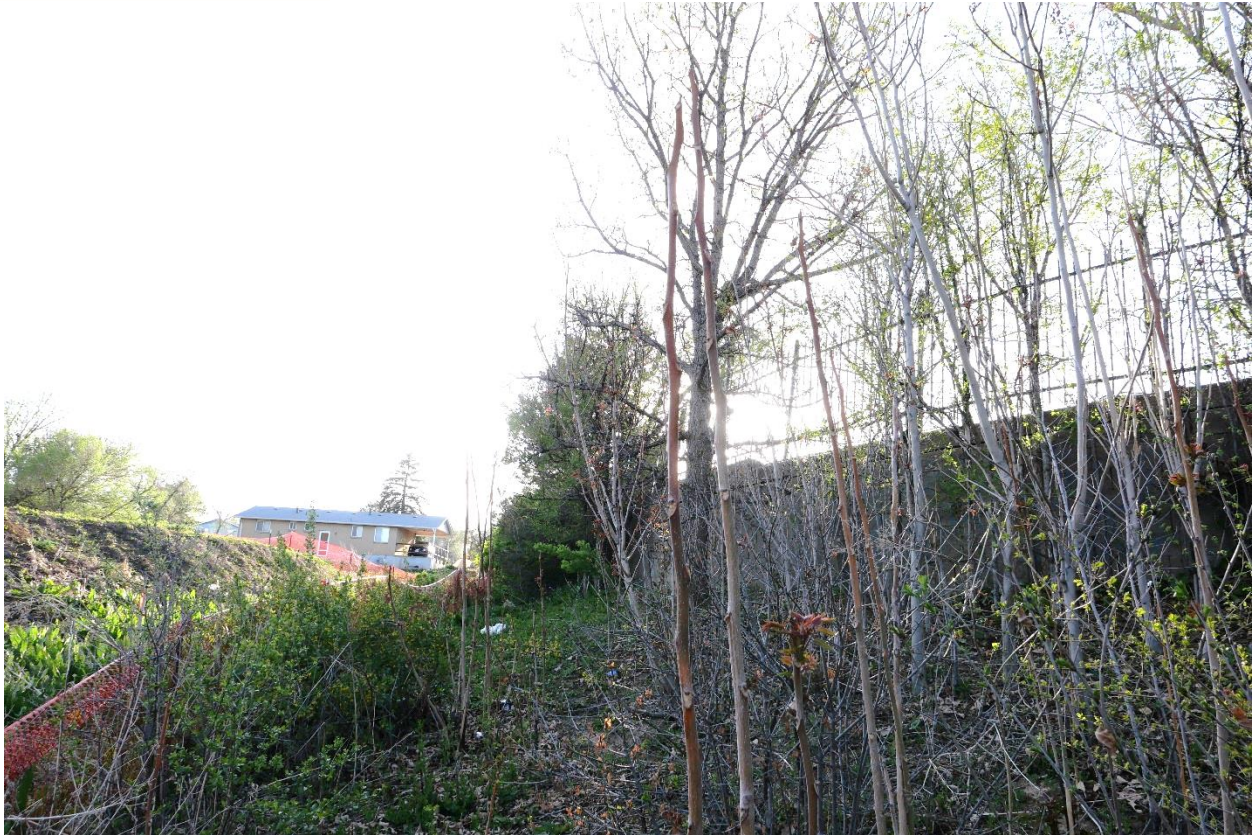
I inventoried an Austrian pine (*Pinus nigra*) 12.0-inch trunk measurement, Pinyon pine (*Pinus edulis*) 6.0-inch trunk measurement, and Bur oak (*Quercus macrocarpa*) 12.0-inch trunk measurement. These trees were intentionally planted, and the pines are in good condition and the oak is excellent. Three volunteer Siberian elms with trunk measurements of 4.5, 6.4, and 7.0 inches have volunteered here. These trees are growing up next to the retaining wall and already have or will conflict with that wall.

Photograph 3.
Landscaping and volunteer trees at Cube Smart Self Storage.

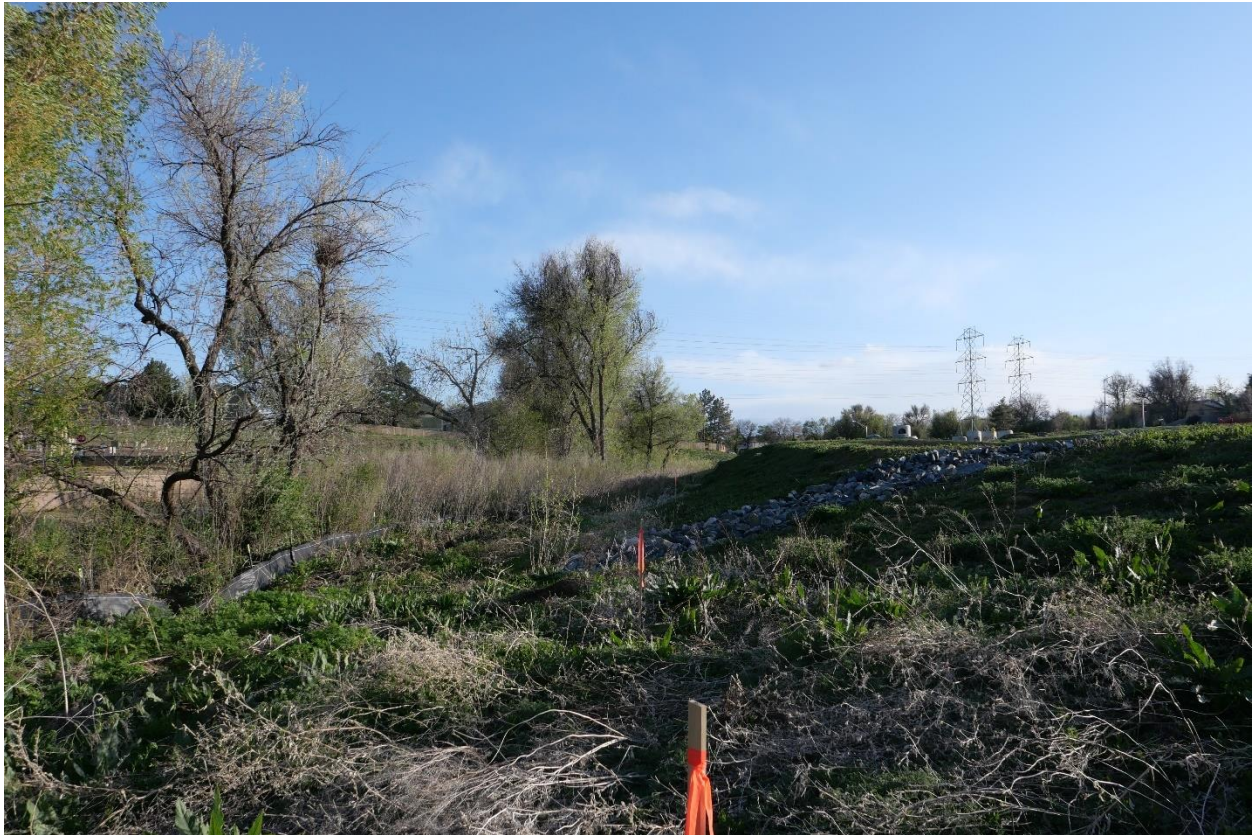
One Siberian elm is close to the subject property. This tree is growing in the water and Aurora Forestry does not require appraisal or mitigation inches for such trees. This tree has an estimated calculated trunk measurement of 19.0 inches and is in fair condition.

Photograph 4.
This is looking south with Woodrim Tributary on the left of the lath stakes and the subject property on the right.
