**MURPHY CREEK  
EXISTING CONDITIONS  
URBAN STREAM ASSESSMENT PROCEDURE**

Prepared for:  
The City of Aurora  
Aurora, Colorado  
and  
The Mile High Flood District  
Lakewood, Colorado

Prepared by:  
Wright Water Engineers, Inc.  
Denver, Colorado

July 15, 2024

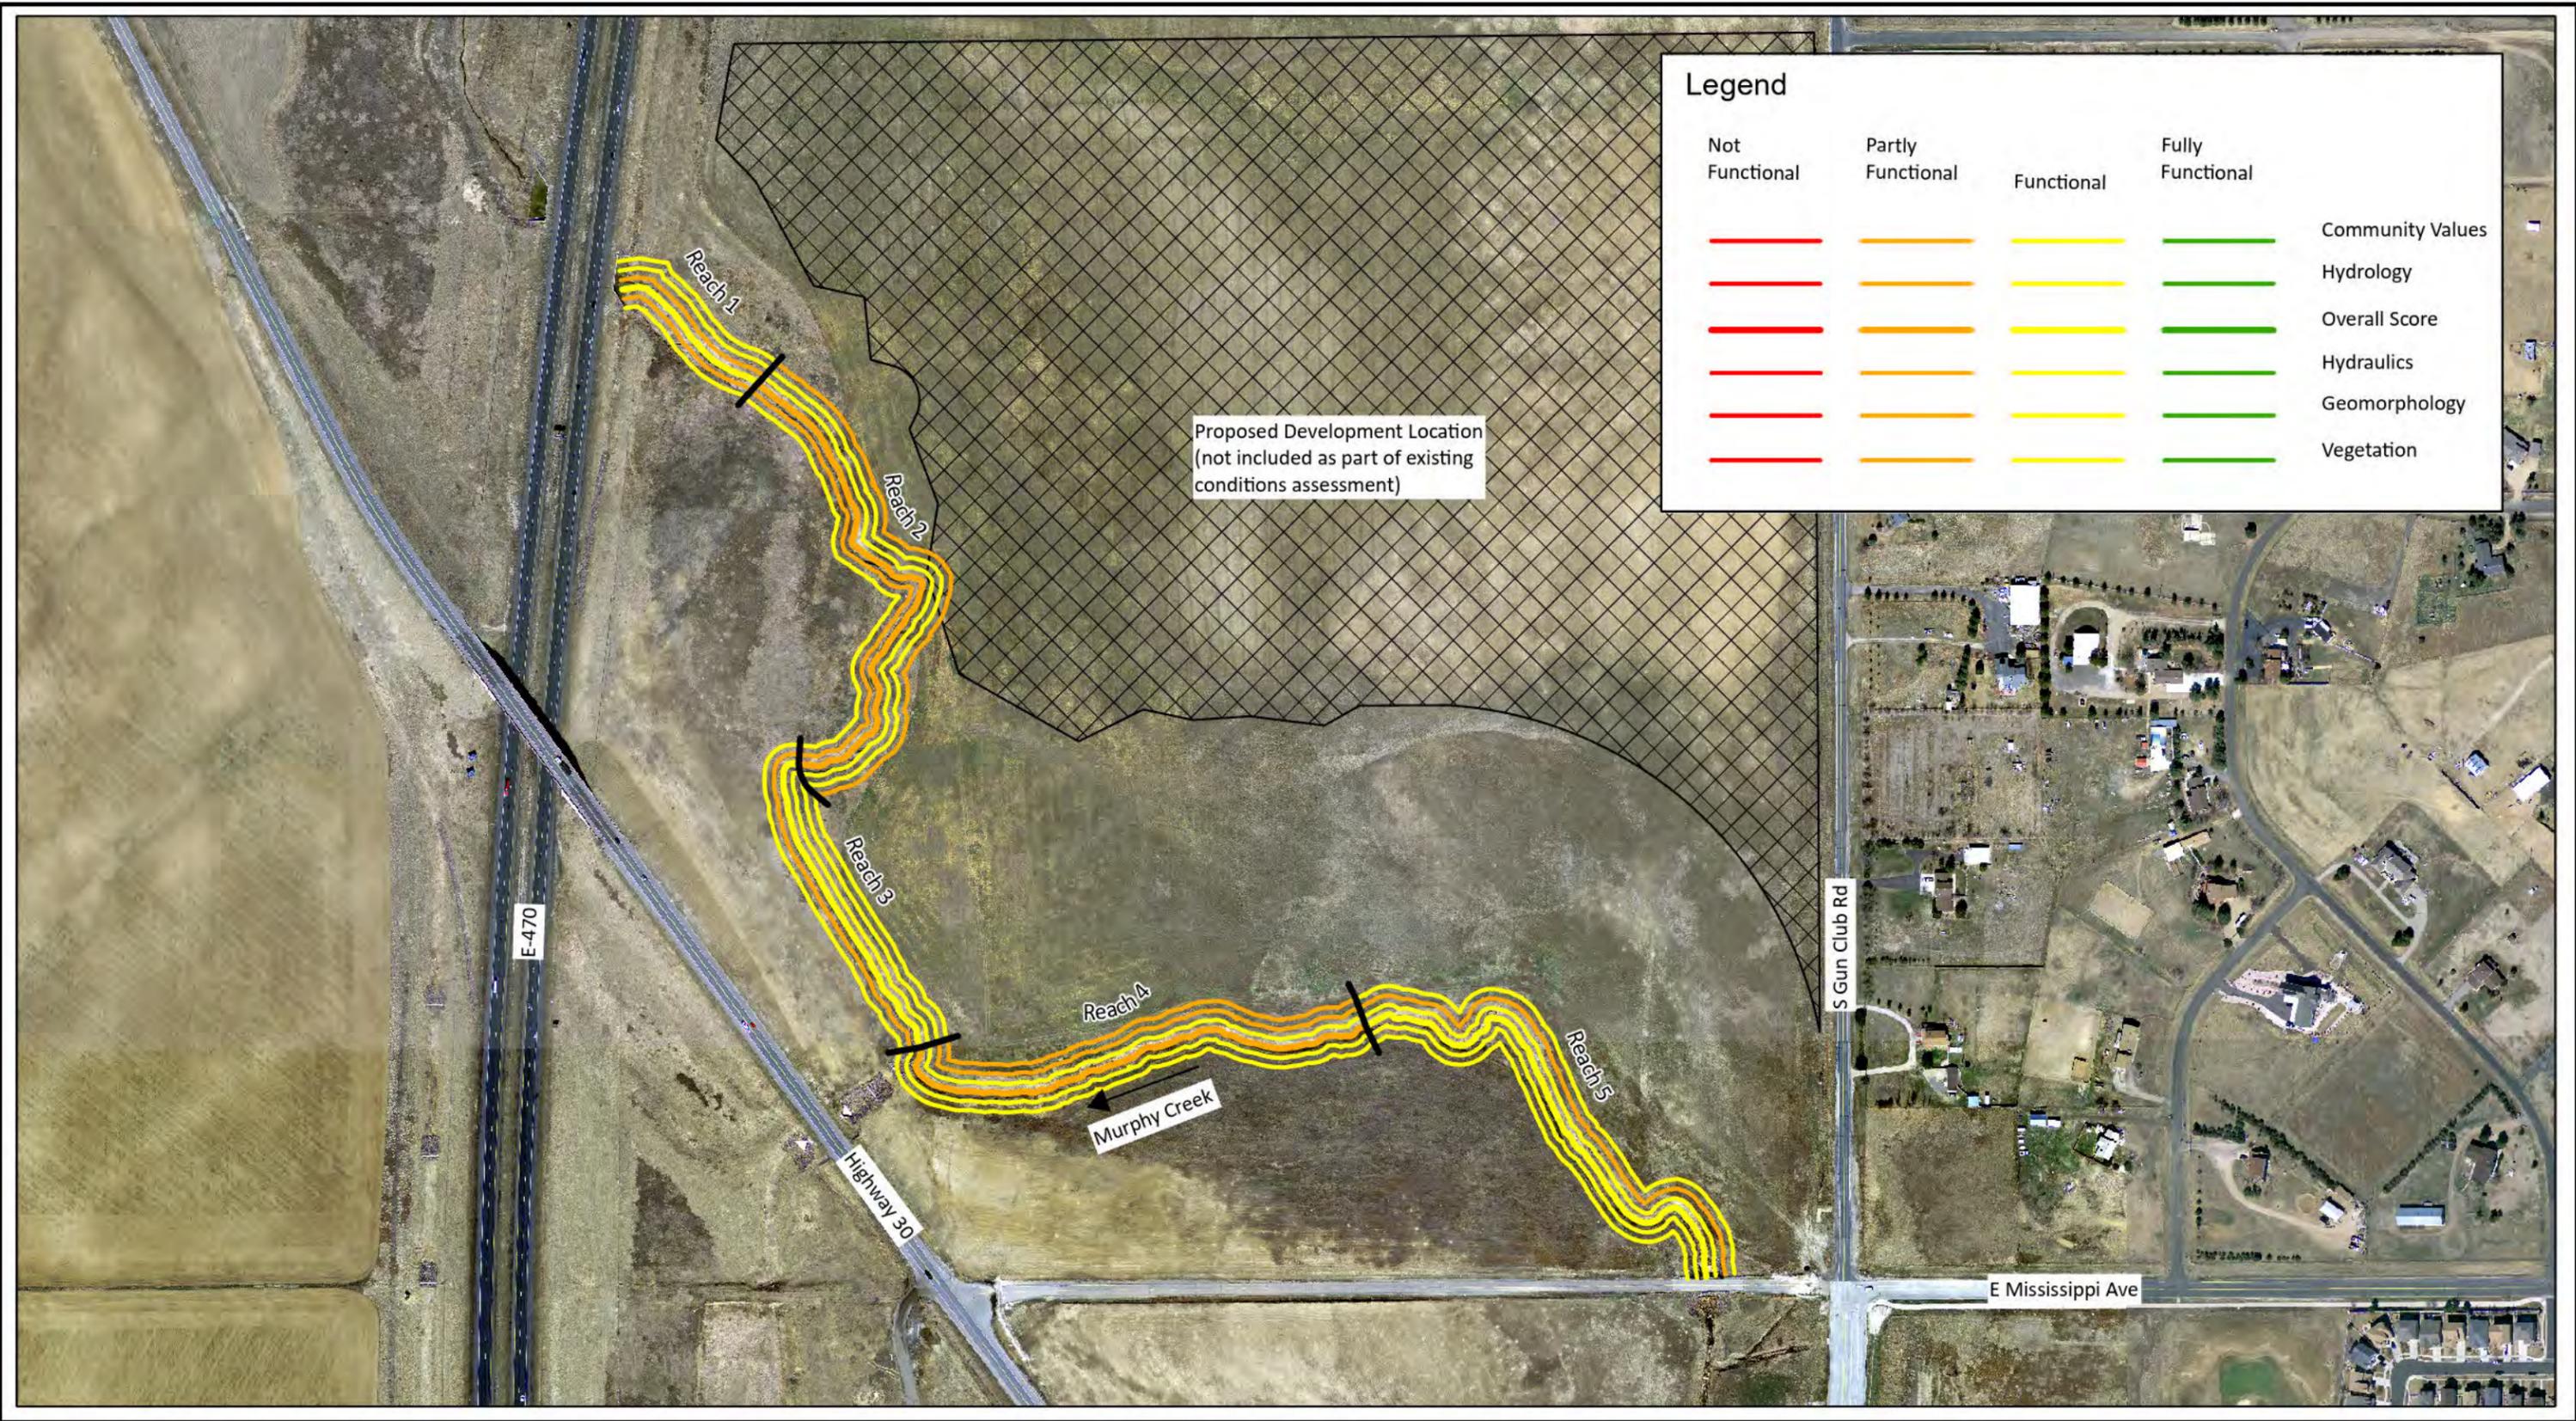
## Appendix 1: USAP Summary Map

Legend				
Not Functional	Partly Functional	Functional	Fully Functional	
				Community Values
				Hydrology
				Overall Score
				Hydraulics
				Geomorphology
				Vegetation

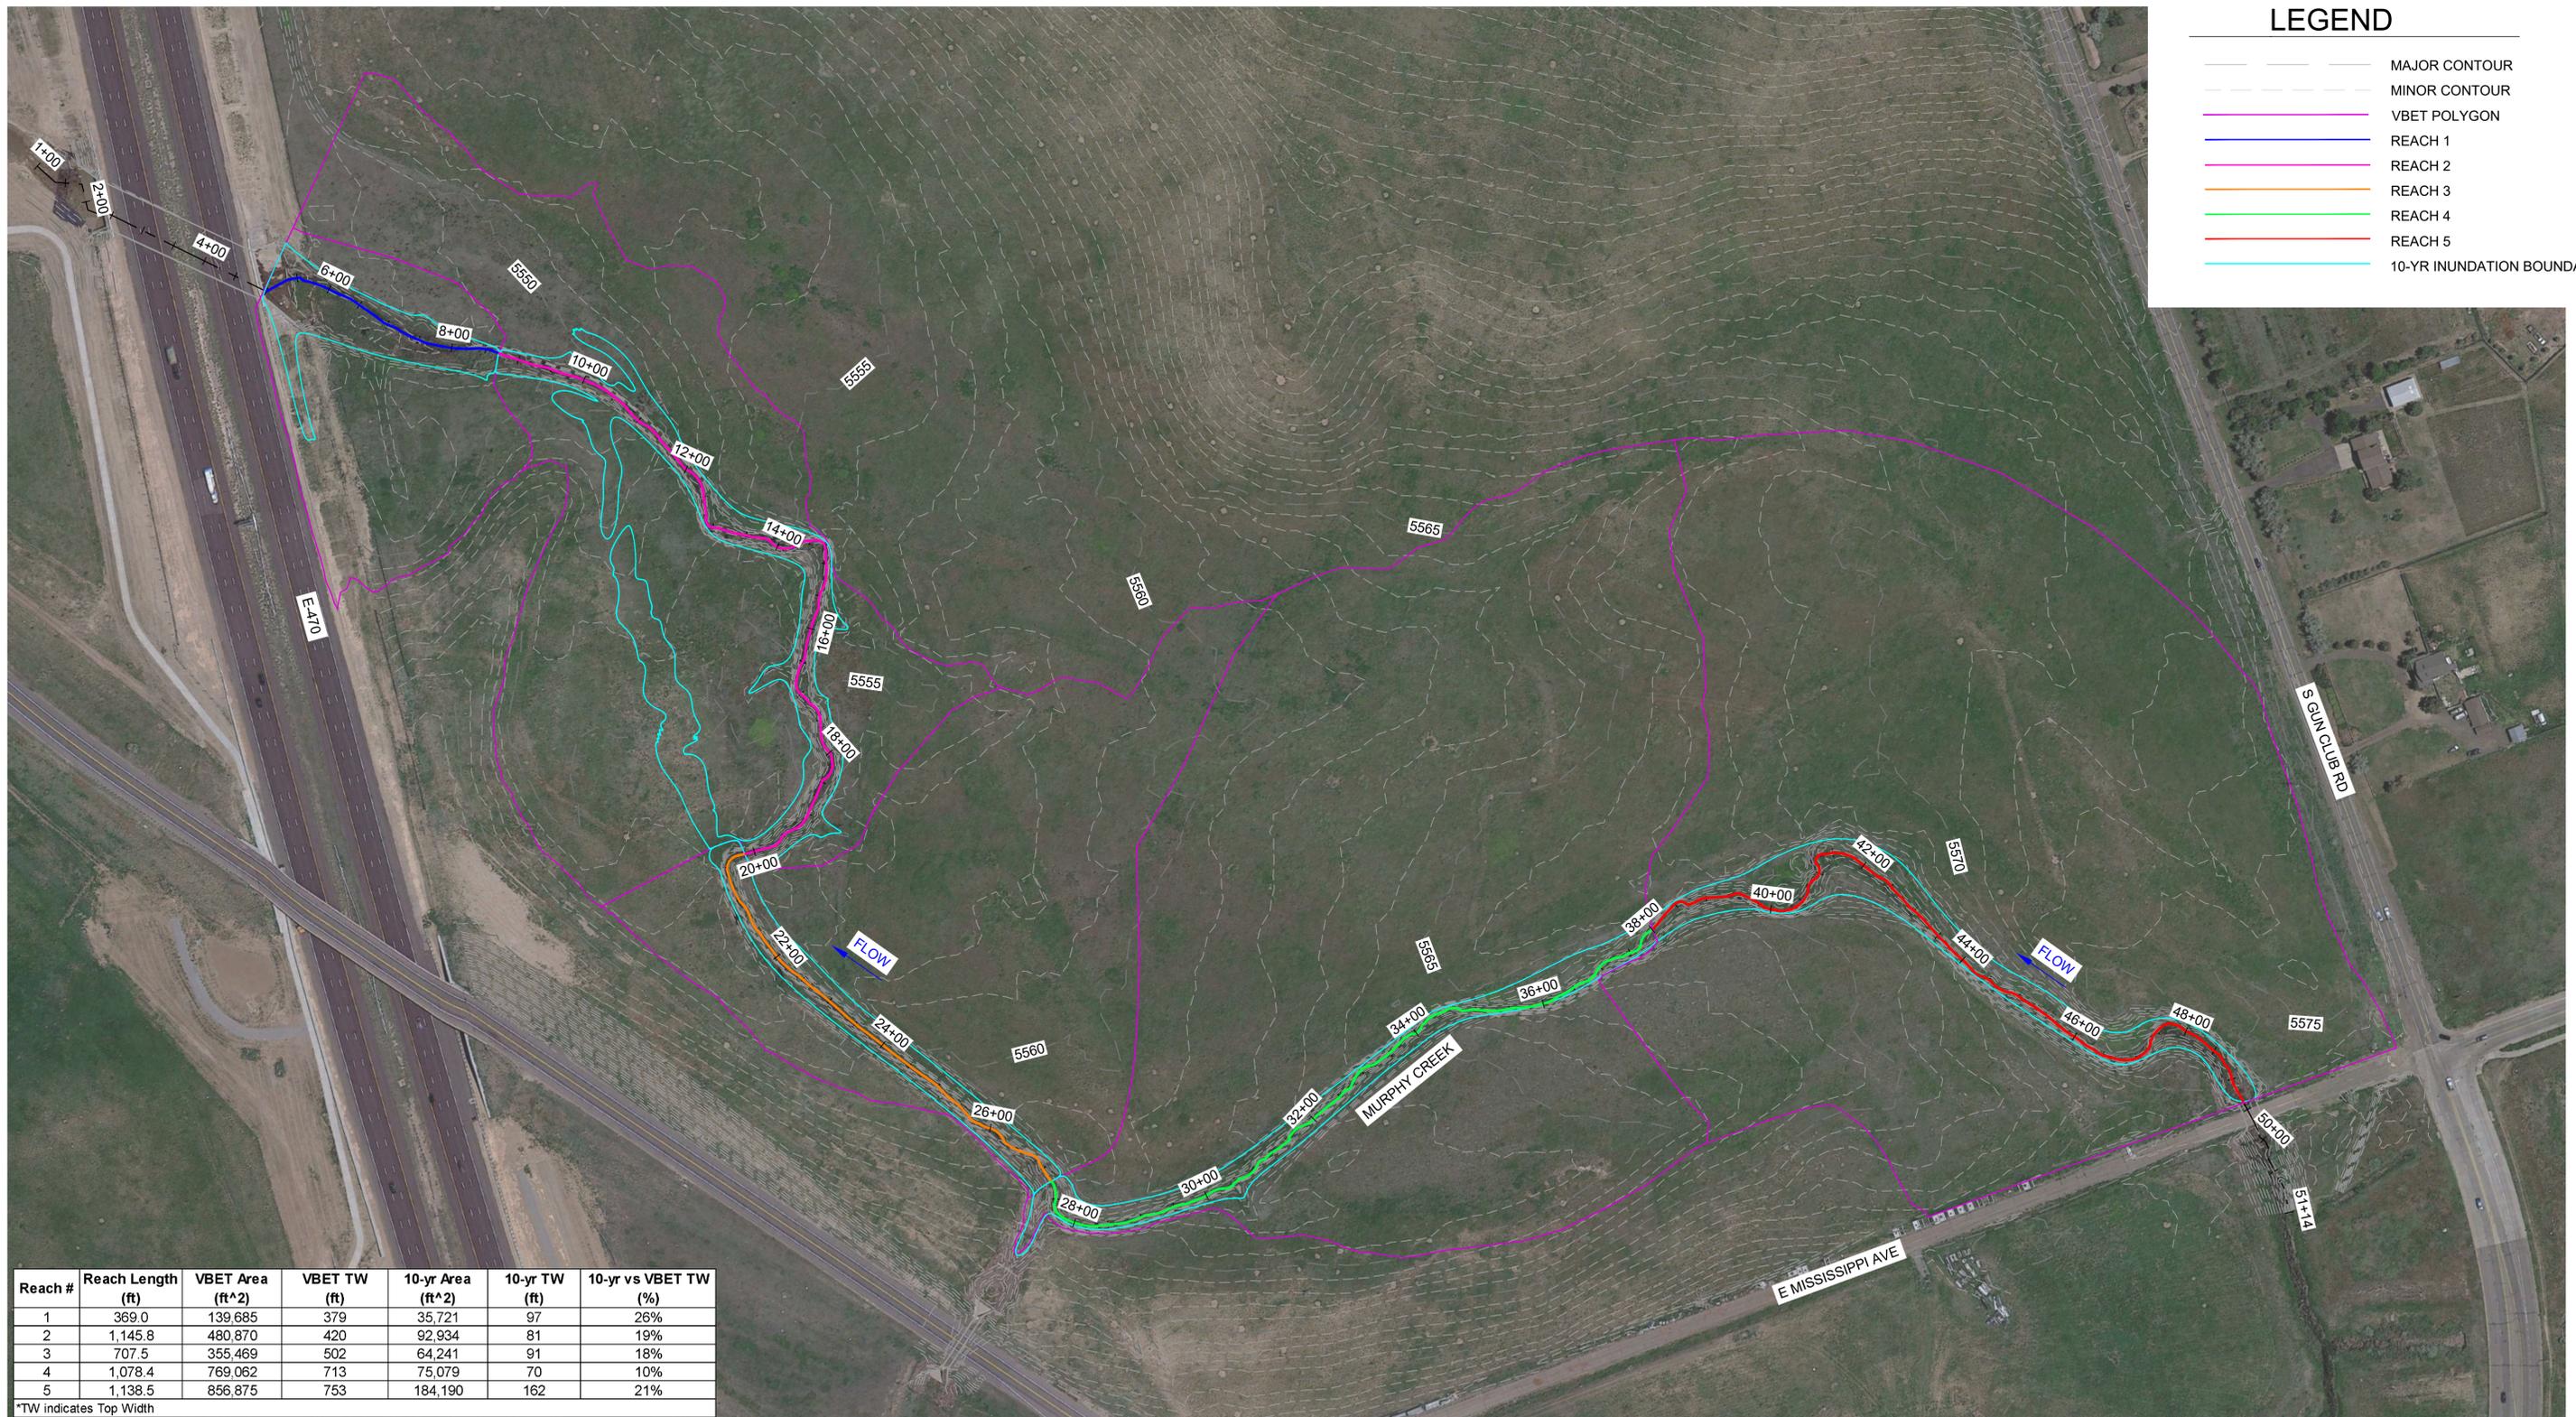
10-YR INUNDATION BOUNDARY

Reach #	Reach Length (ft)	VBET Area (ft <sup>2</sup> )	VBET TW (ft)	10-yr Area (ft <sup>2</sup> )	10-yr TW (ft)	10-yr vs VBET TW (%)
1	369.0	139,685	379	35,721	97	26%
2	1,145.8	480,870	420	92,934	81	19%
3	707.5	355,469	502	64,241	91	18%
4	1,078.4	769,062	713	75,079	70	10%
5	1,138.5	856,875	753	184,190	162	21%

\*TW indicates Top Width

The floodplain connectivity ratio was evaluated using the Valley Bottom Extraction Tool (VBET) (Gilbert et al., 2016), which generates a delineation of the estimated valley bottom polygon (see Appendix 5). The frequency upon which this area is inundated was then evaluated using the existing conditions two-dimensional hydraulic model for Murphy Creek. The scoring for this metric assesses how frequently the floodplain is inundated at "moderate intervals." For this evaluation, "moderate intervals" was defined as the 10-year event. Generally, the Study Area has high banks that prevent the floodplain outside the main channel from being inundated during events less than or equal to the 10-year event. This results in a floodplain that is infrequently inundated compared to the potential floodplain area identified by the VBET tool and led to a 'not functional' score.

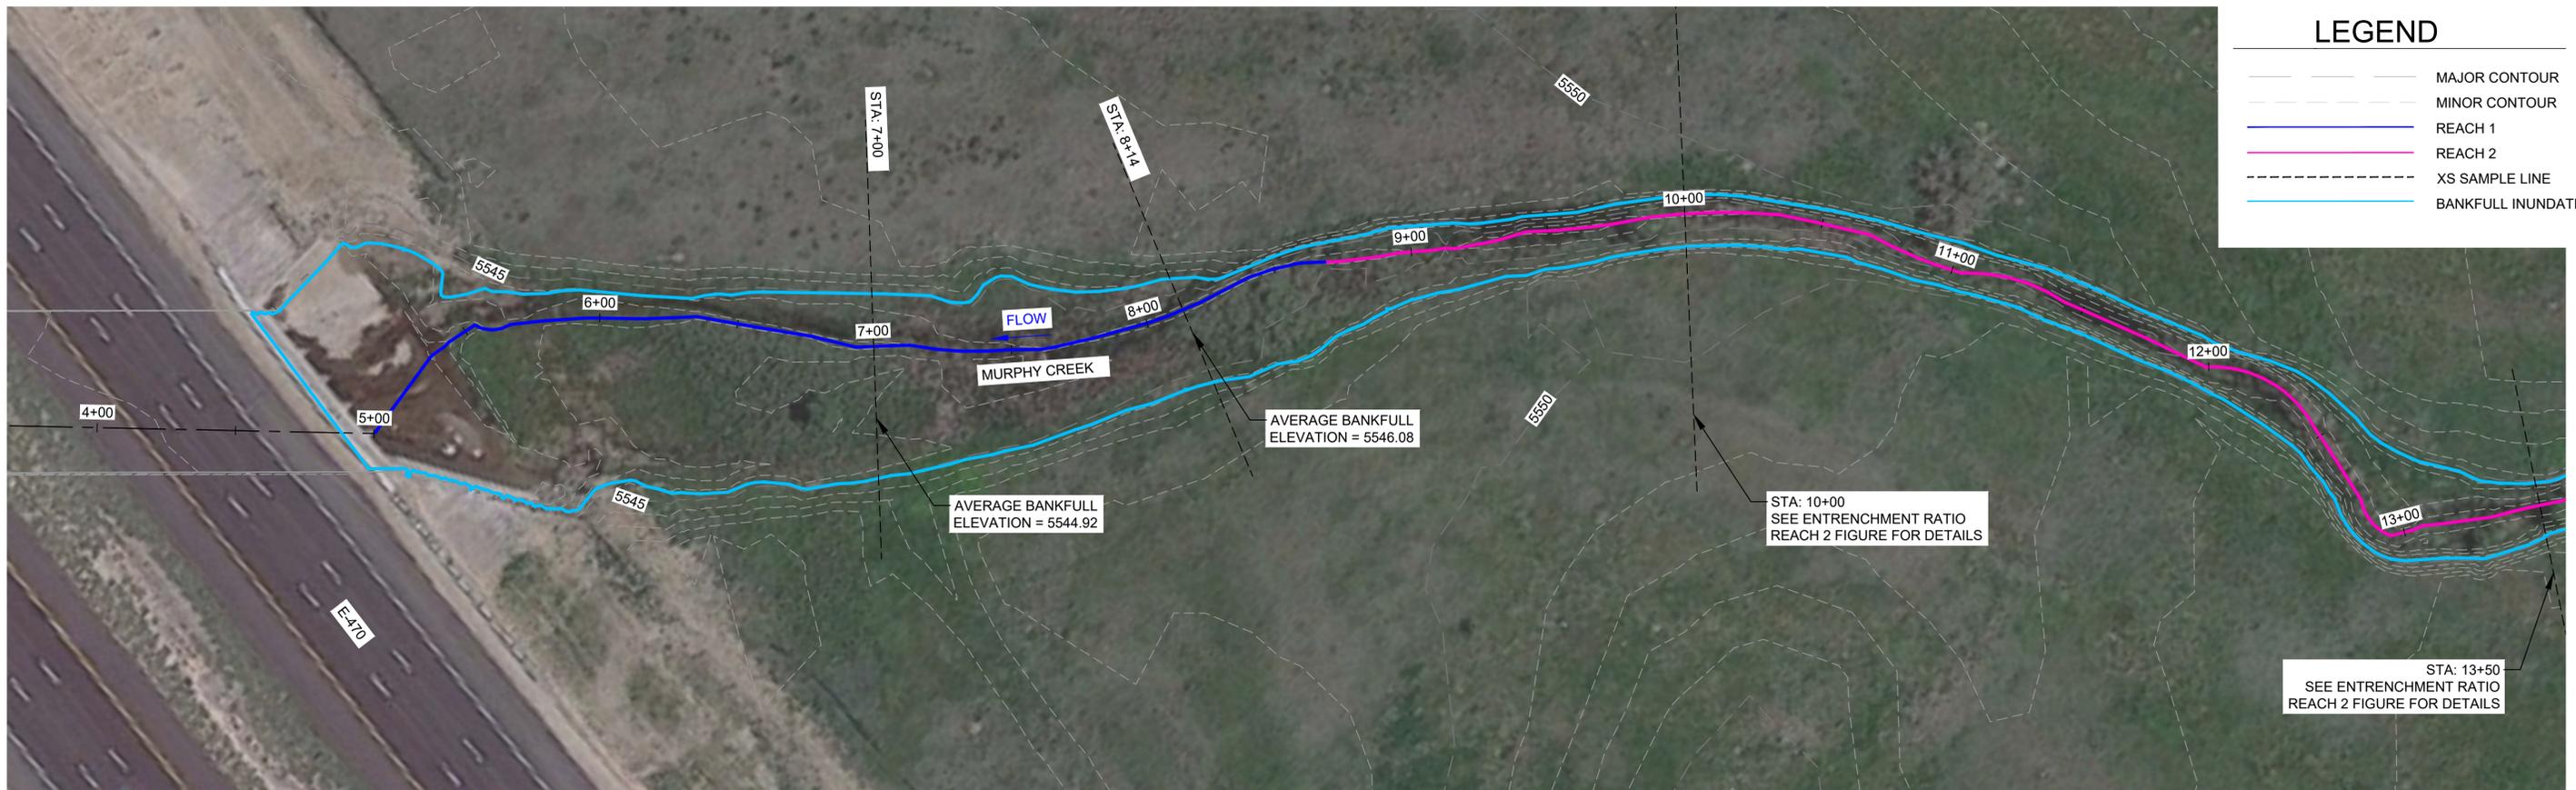
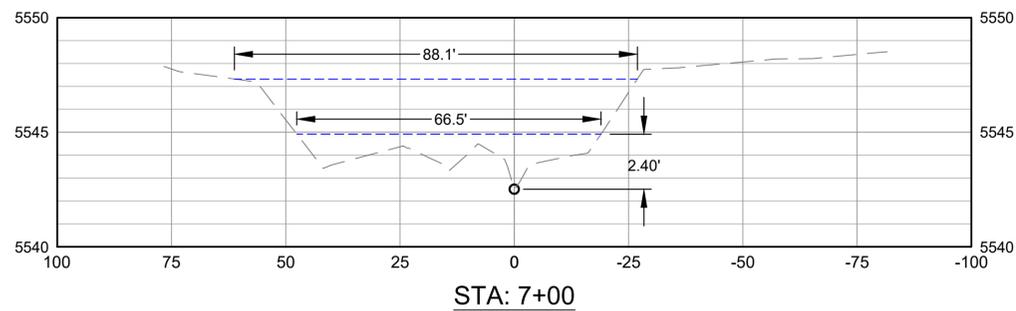
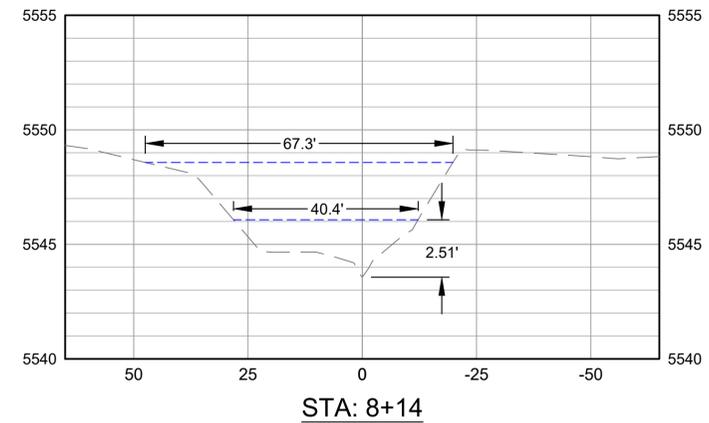
Reach #	Station	Bankfull Depth (ft)	Bankfull Width (ft)	Bankfull Width @ 2X Bankfull Depth (ft)	Entrenchment Ratio	Average Entrenchment Ratio for Reach	USAP Score
1	7+00	2.40	66.5	88.1	1.32	1.50	1
	8+14	2.51	40.4	67.3	1.67

The entrenchment ratio is a quantitative metric calculated by taking the ratio of the width of the flood-prone area to the surface width of the bankfull channel. The bankfull channel limits were estimated using field indicators and hydraulic modeling. WWE found that the inundation boundary produced at 70% of the 2-year flow rate correlated well with the limits of the observed bankfull channel; therefore, this flow rate was used to approximate bankfull for the purposes of this analysis. Representative cross sections were taken for each reach, measuring the surface width of the bankfull channel and the surface width at twice the bankfull channel depth. The entrenchment ratio was then calculated for each reach, and the reaches were scored based on the value of this ratio (see Appendix 6).

Using 70% of the 2-year event as the bankfull flow rate, WWE compared this bankfull channel surface width to twice the bankfull channel depth surface width for Reach 1. For Reach 1, the entrenchment ratio was 1.5, resulting in a score of ‘partly functional’. Due to the realignment of Murphy Creek and aggradation resultant of the construction of E-470, this reach features a wider bankfull channel than the dimension observed elsewhere in the Study Area, resulting in the relatively lower score.

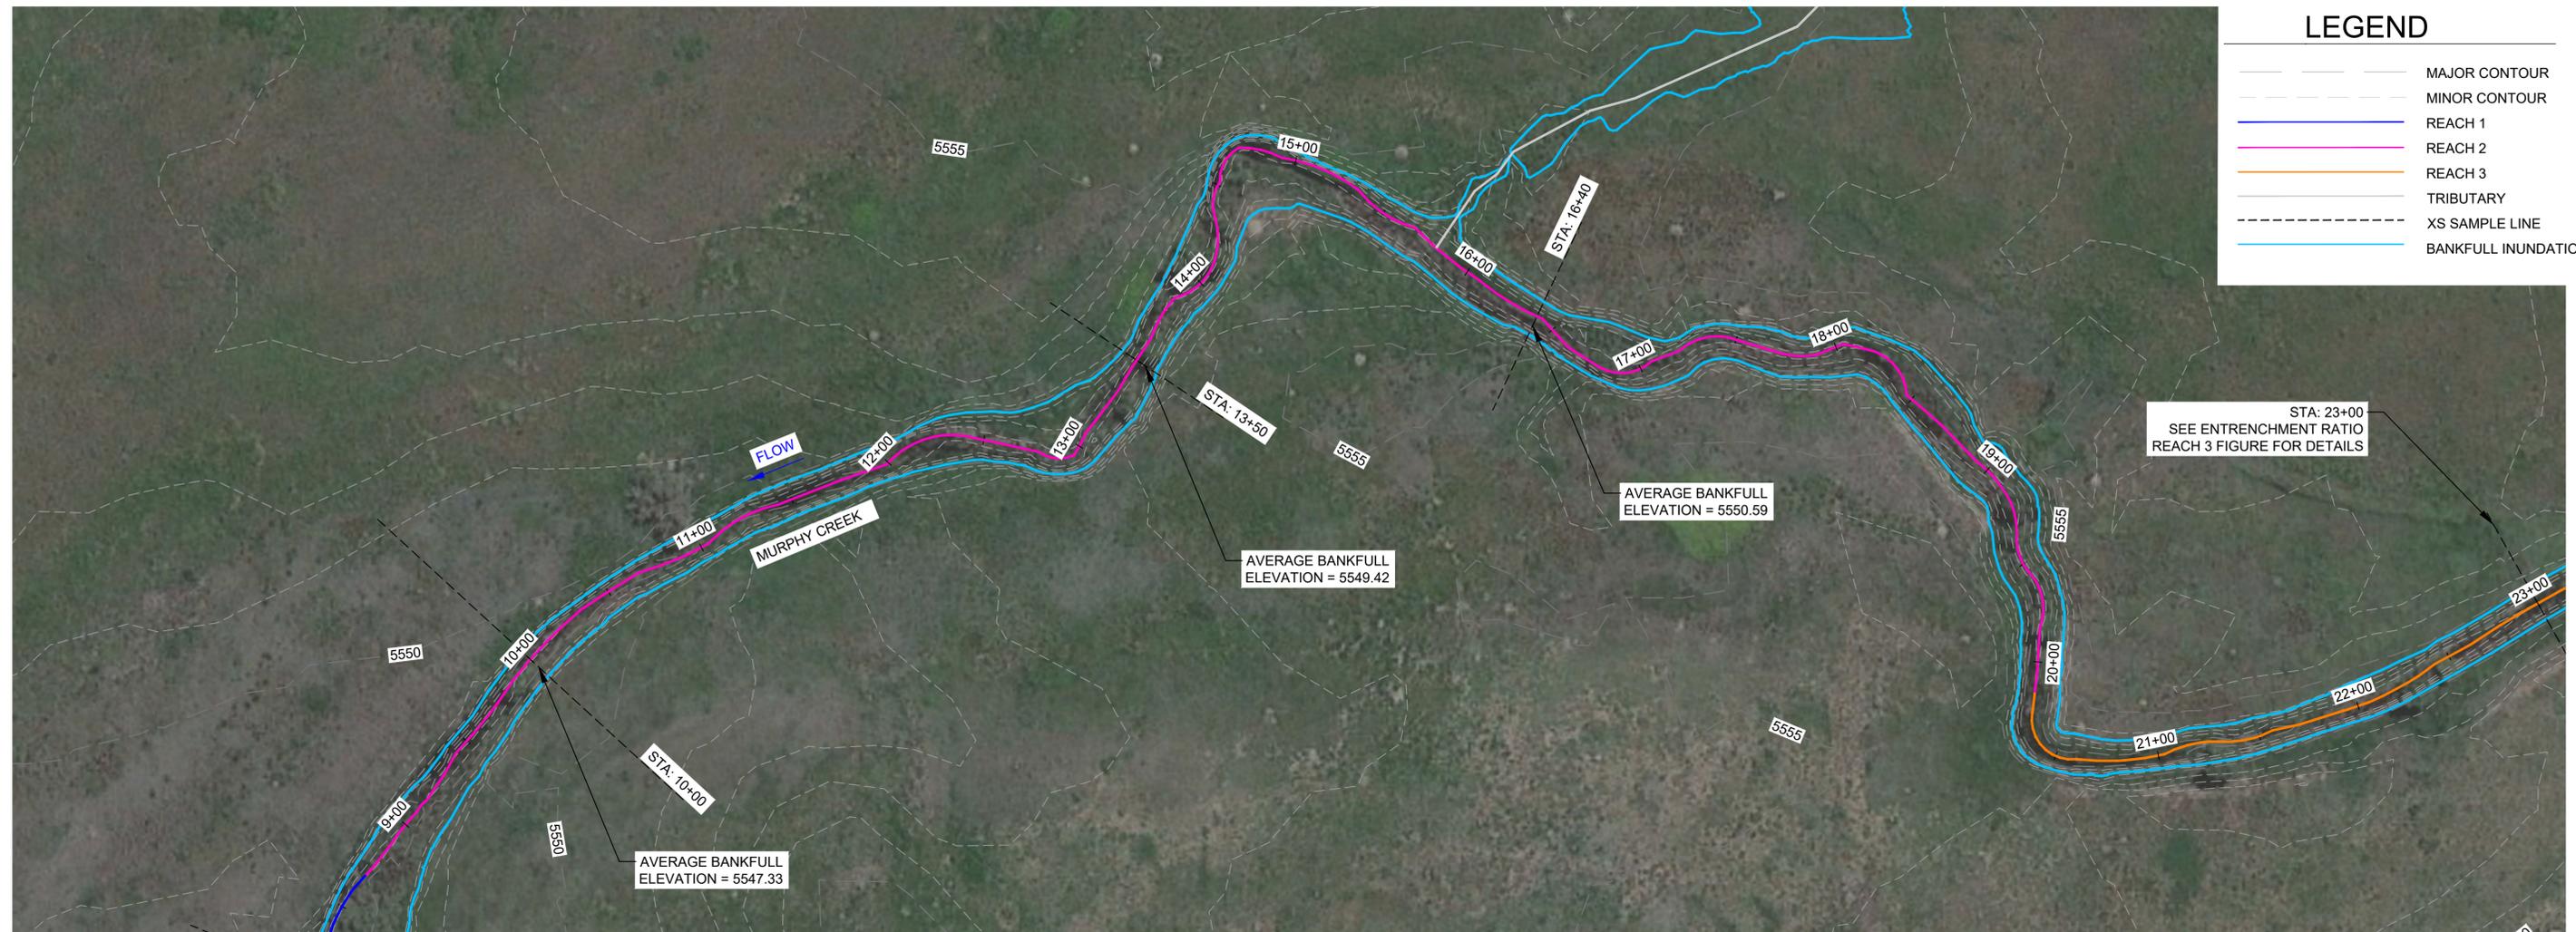
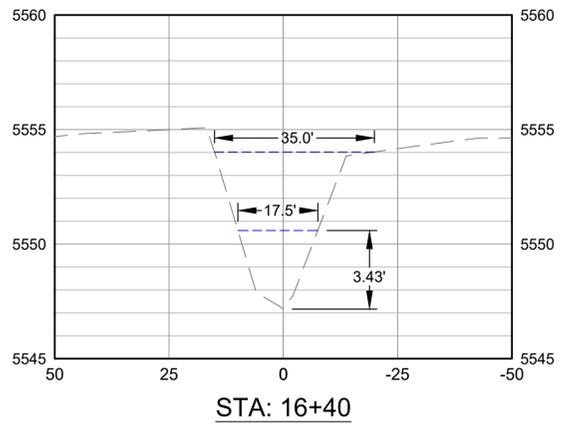
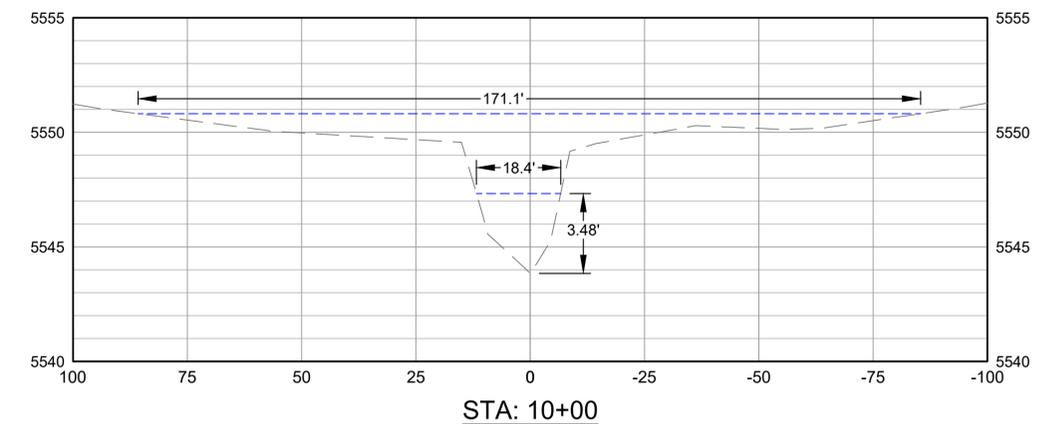
Reach #	Station	Bankfull Depth (ft)	Bankfull Width (ft)	Bankfull Width @ 2X Bankfull Depth (ft)	Entrenchment Ratio	Average Entrenchment Ratio for Reach	USAP Score
2	10+00	3.48	18.4	171.1	9.29	4.78	3
	13+50	4.02	19.5	59.4	3.05		
	16+40	3.43	17.5	35.0	2.00

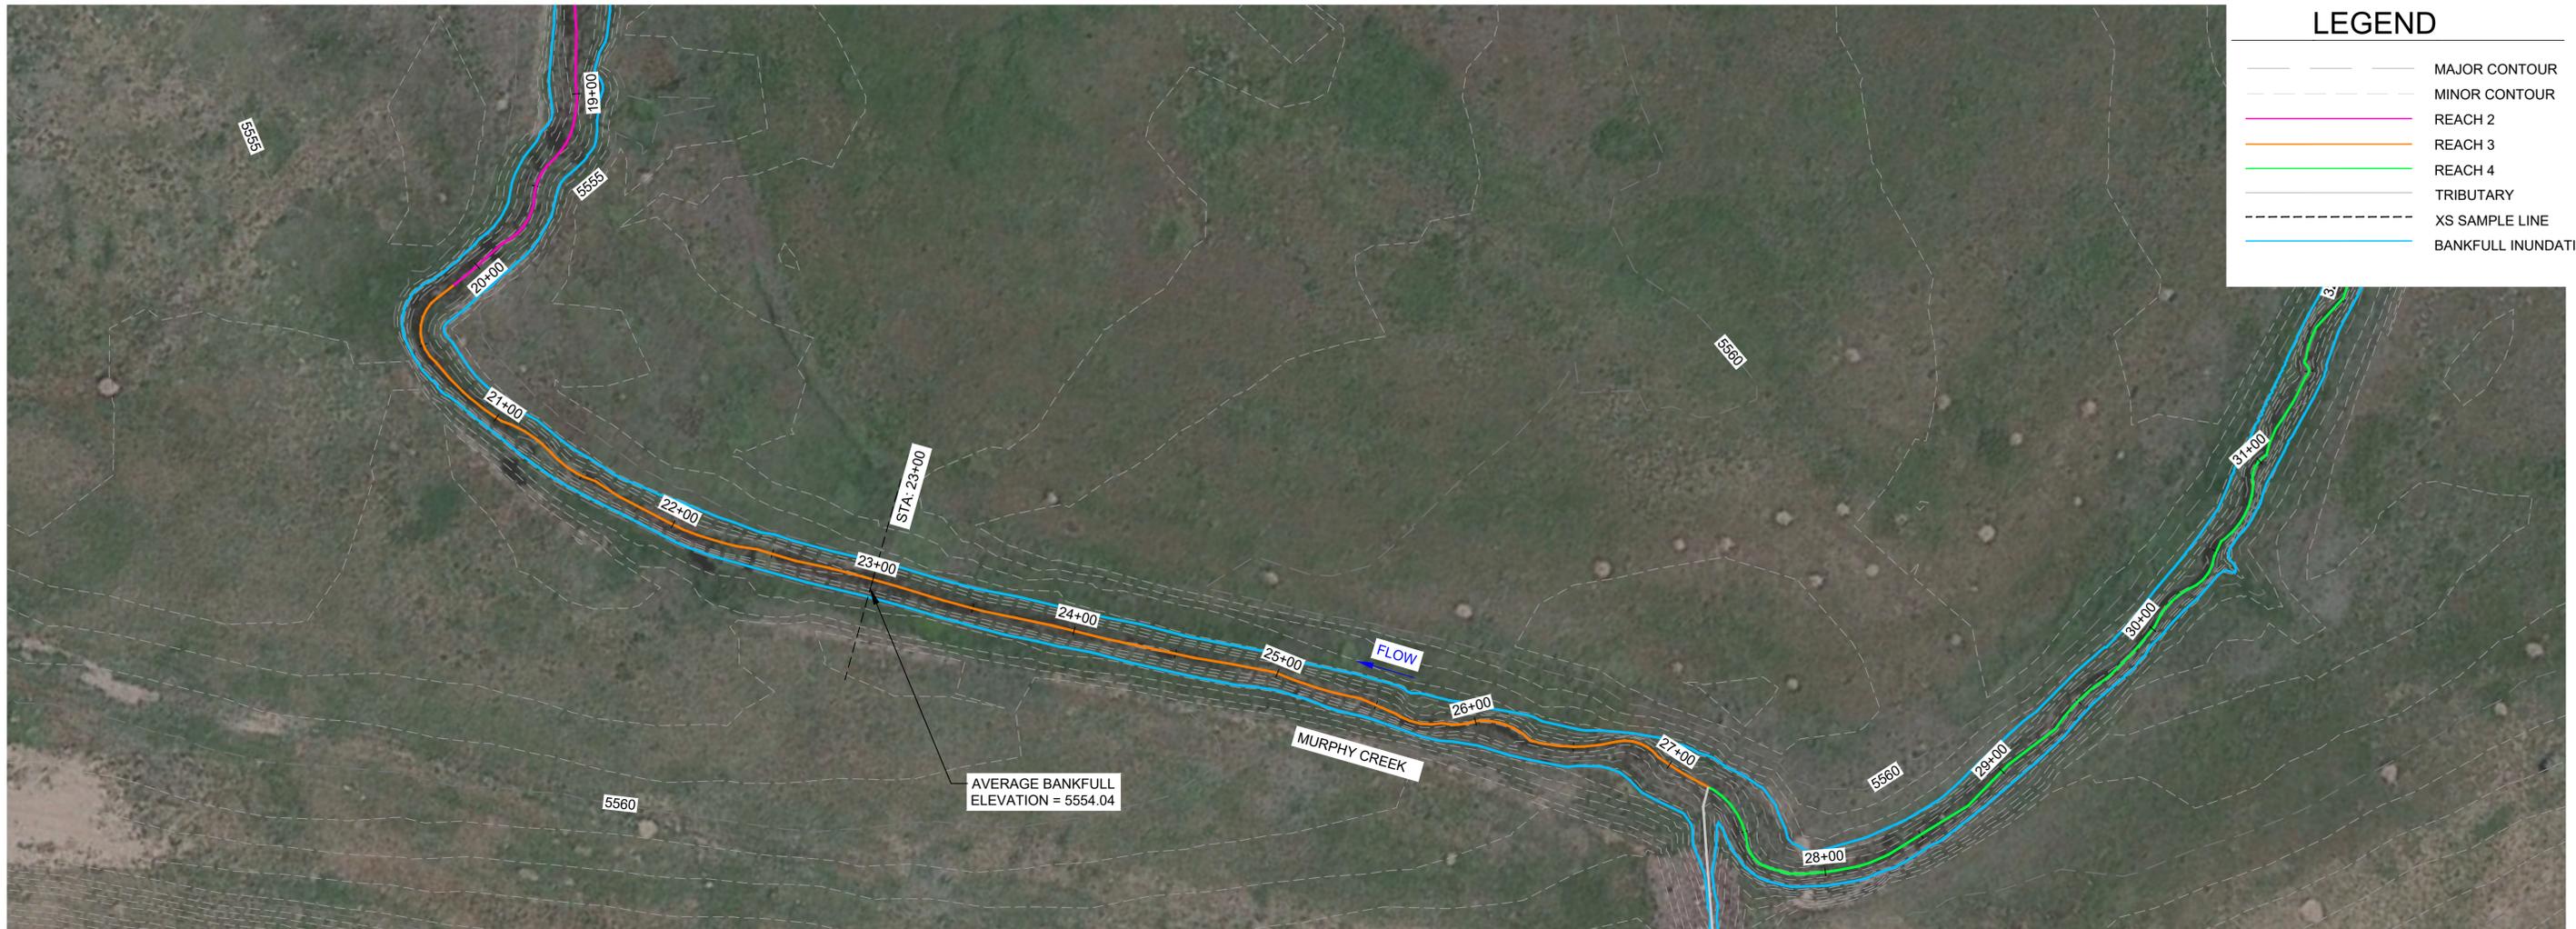
Reach #	Station	Bankfull Depth (ft)	Bankfull Width (ft)	Bankfull Width @ 2X Bankfull Depth (ft)	Entrenchment Ratio	Average Entrenchment Ratio for Reach	USAP Score
3	23+00	3.08	17.5	50.9	2.90	2.90	3

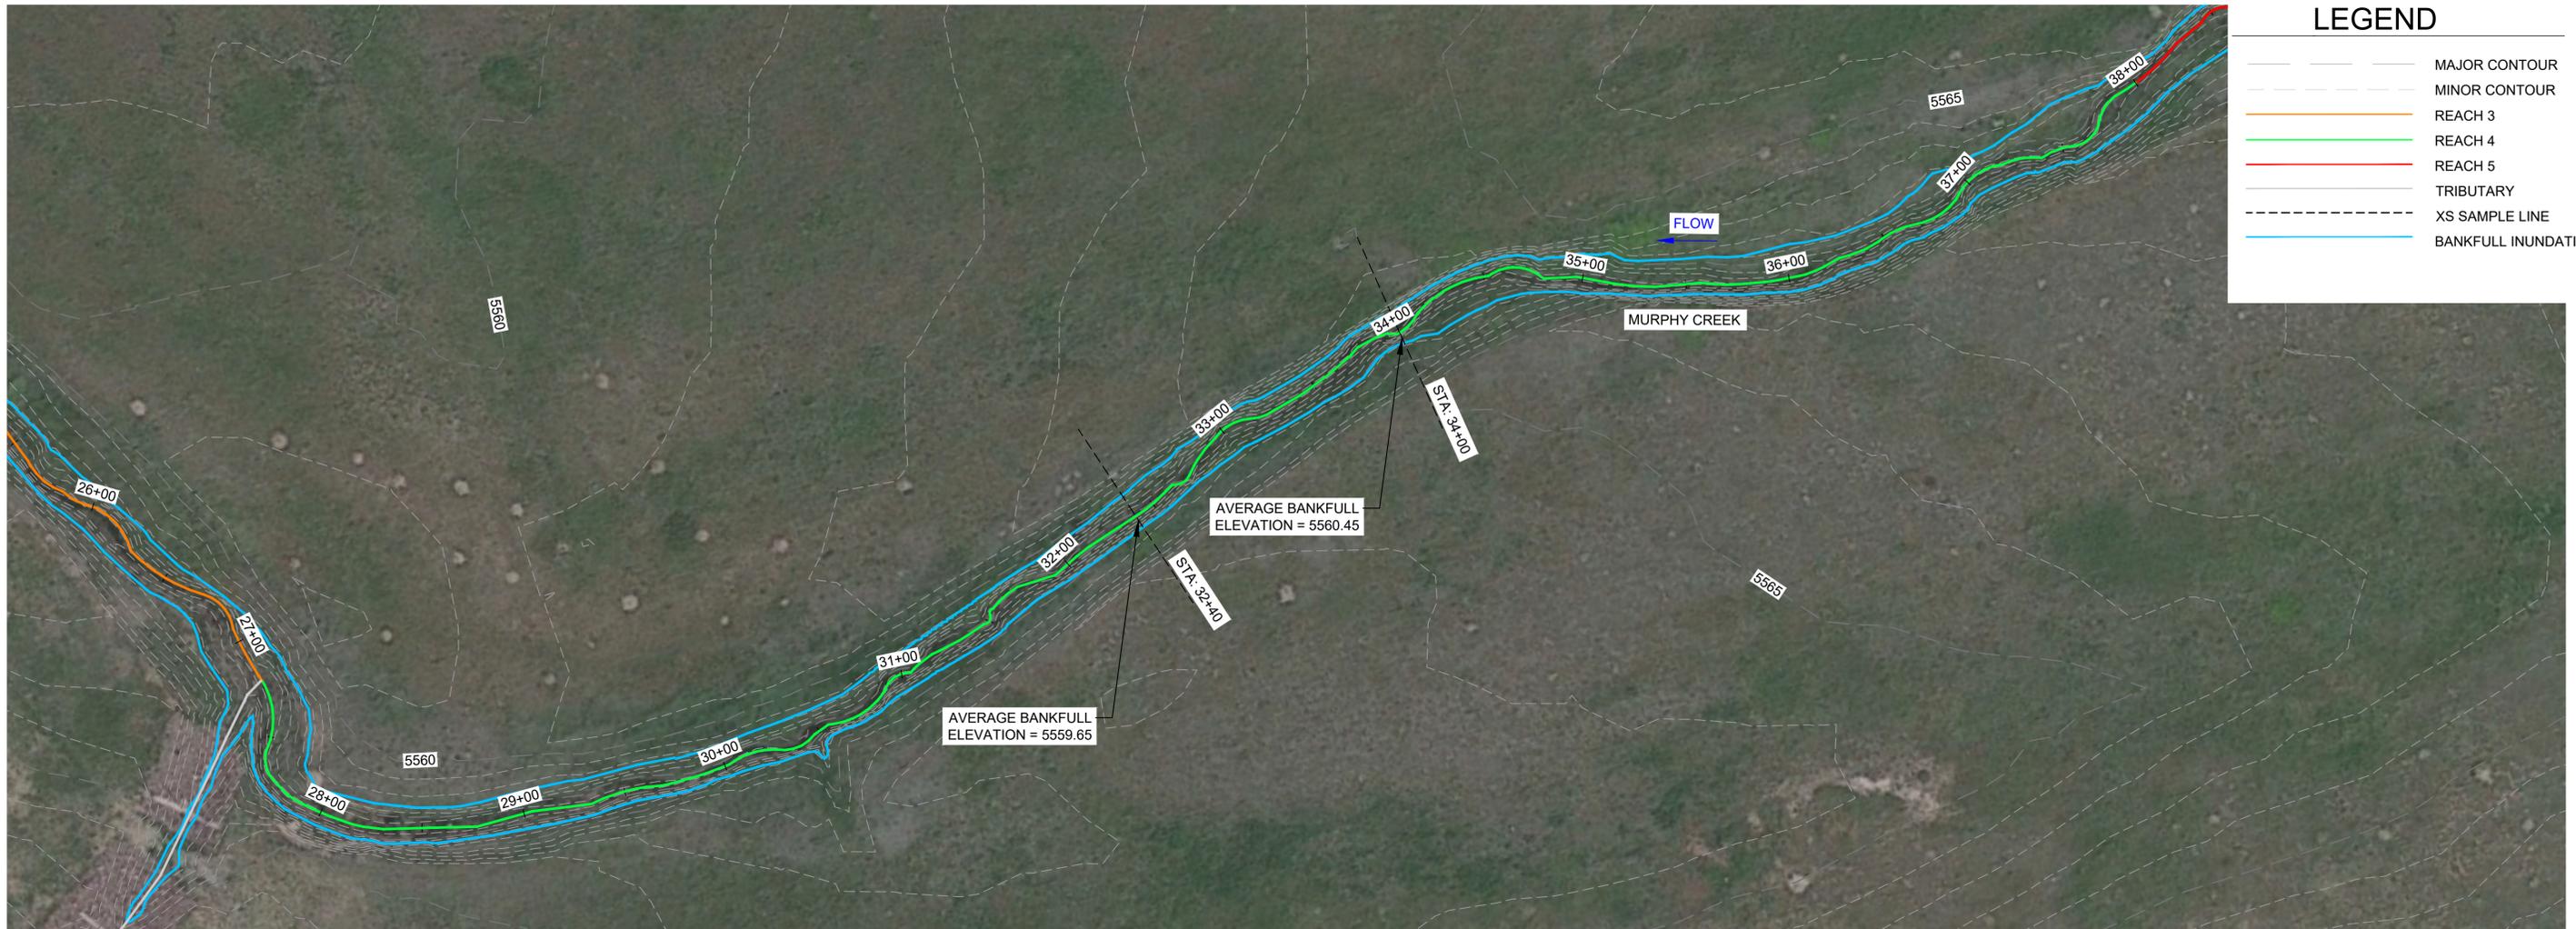
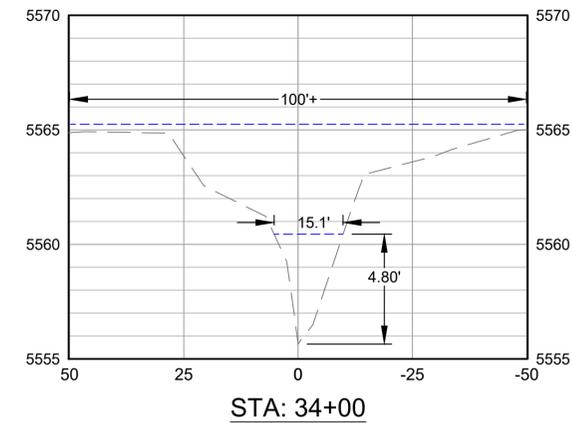
Reach #	Station	Bankfull Depth (ft)	Bankfull Width (ft)	Bankfull Width @ 2X Bankfull Depth (ft)	Entrenchment Ratio	Average Entrenchment Ratio for Reach	USAP Score
4	32+40	5.11	18.4	100+	5.43	6.02	3
	34+00	4.80	15.1	100+	6.62

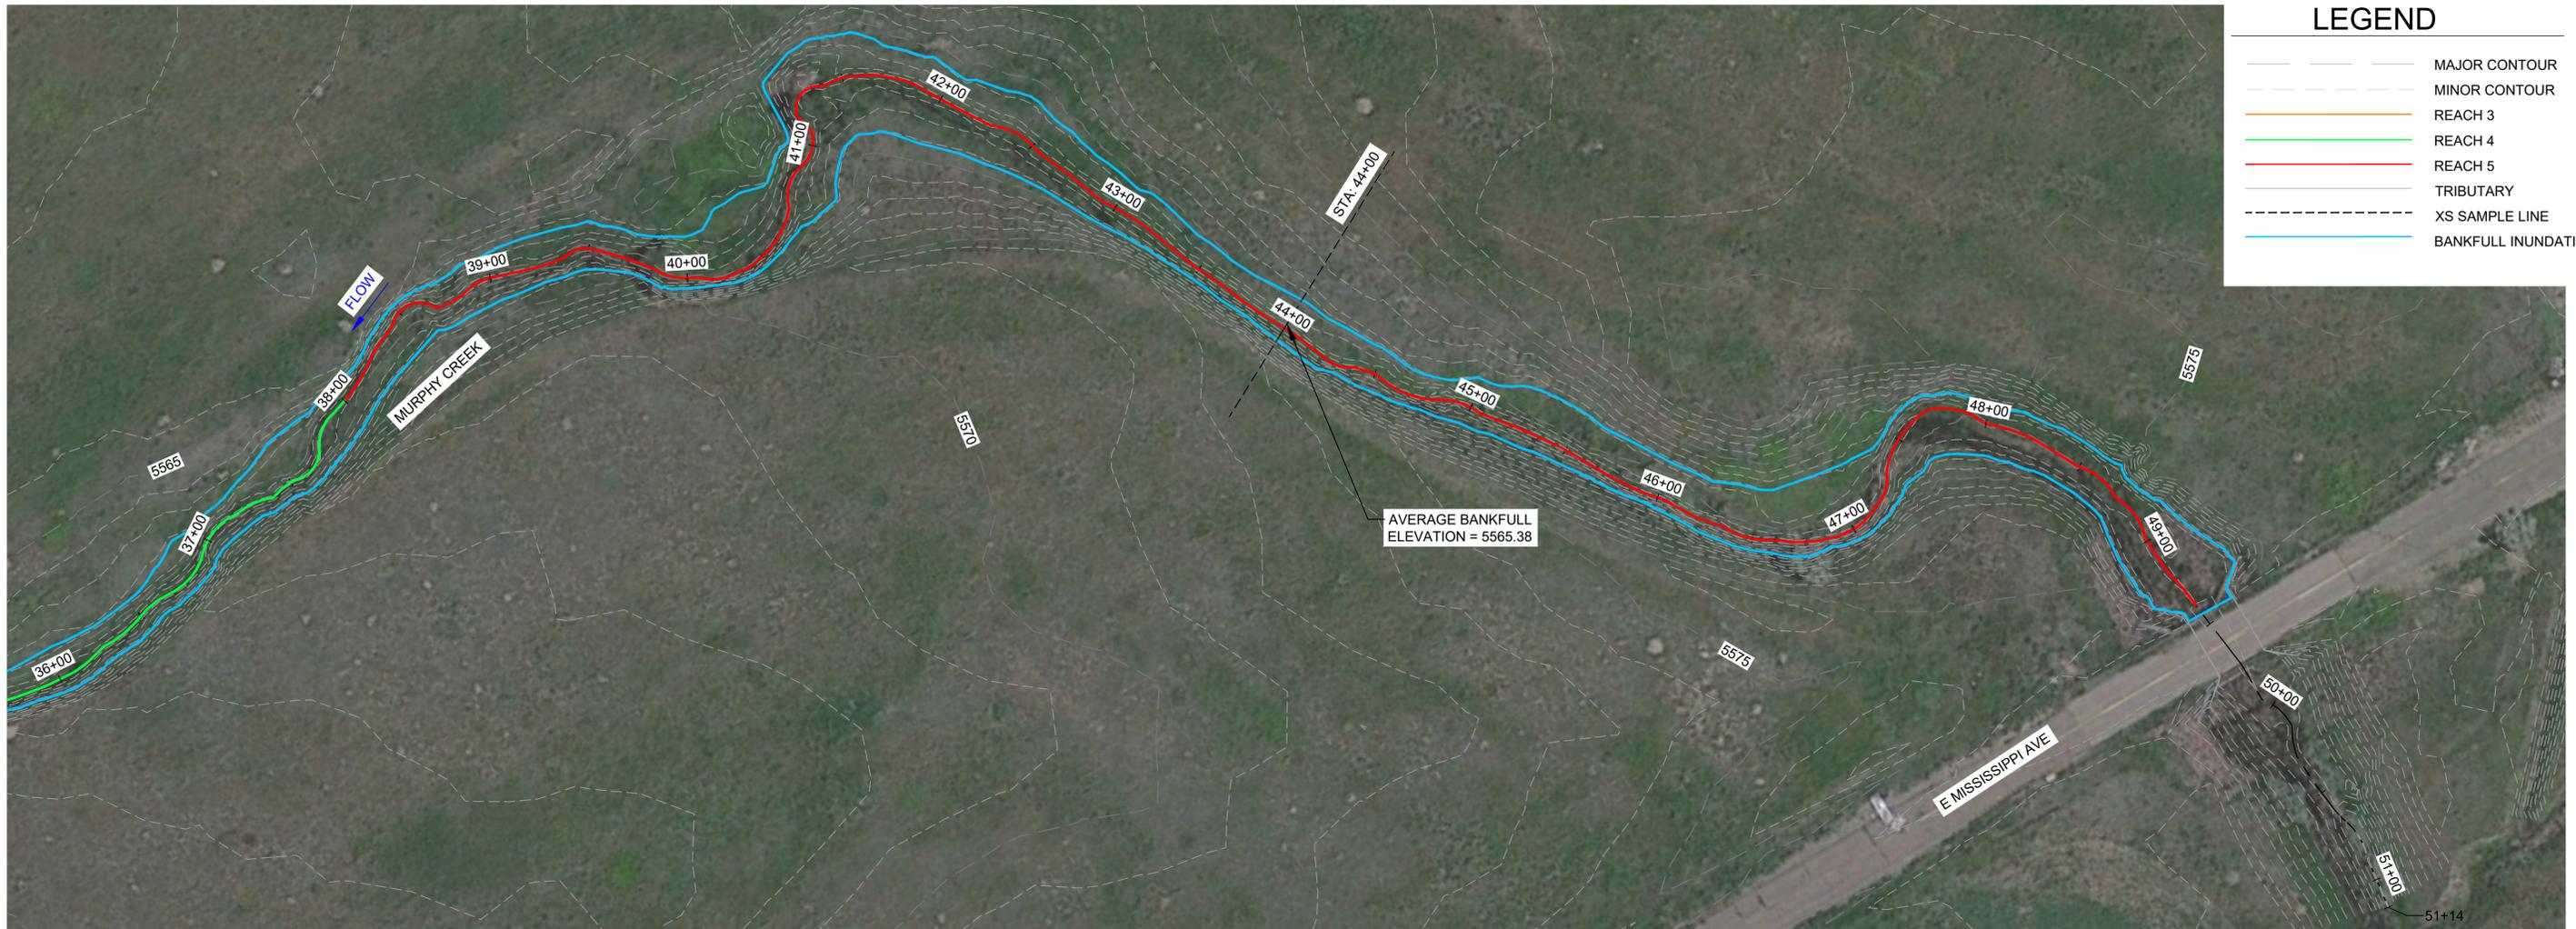
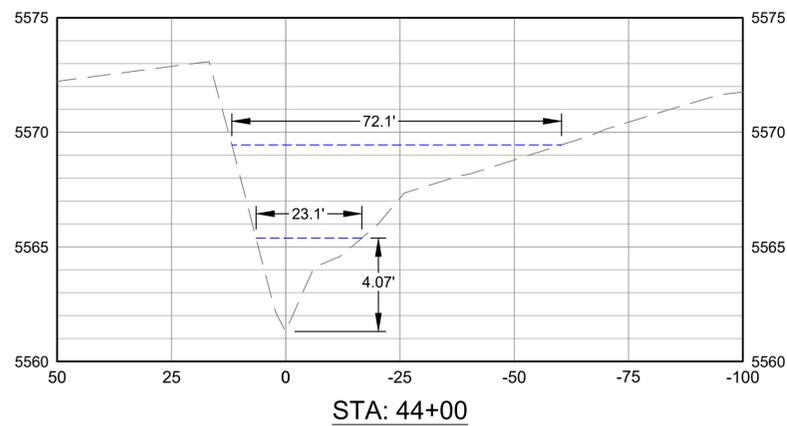
Reach #	Station	Bankfull Depth (ft)	Bankfull Width (ft)	Bankfull Width @ 2X Bankfull Depth (ft)	Entrenchment Ratio	Average Entrenchment Ratio for Reach	USAP Score
5	44+00	4.07	23.1	72.1	3.12	3.12	3

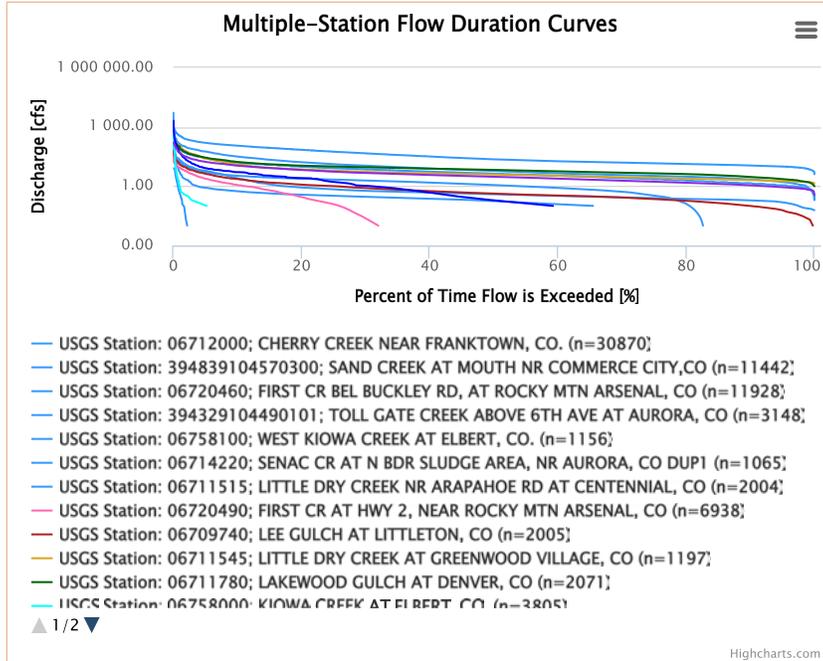
A flow duration curve (FDC) is the ranked graphing of river flows on a scale of percent exceedance. For example a flow value associated with the flow interval of 15% means that particular flow value is met or exceeded only 15% of the time. This graph is meant to give a quick overview of the flow ranges, variability, and probability of flows of a river segment during the different flow periods of a river; which are High from 0 to 10 percent flow interval, Moist Conditions 10-40, Mid-Range Flows 40-60, Dry Conditions 60-90, and Low Flows 90-100 (Cleland 2003).
