**MURPHY CREEK  
EXISTING CONDITIONS  
URBAN STREAM ASSESSMENT PROCEDURE**

Prepared for:  
The City of Aurora  
Aurora, Colorado  
and  
The Mile High Flood District  
Lakewood, Colorado

Prepared by:  
Wright Water Engineers, Inc.  
Denver, Colorado

July 15, 2024

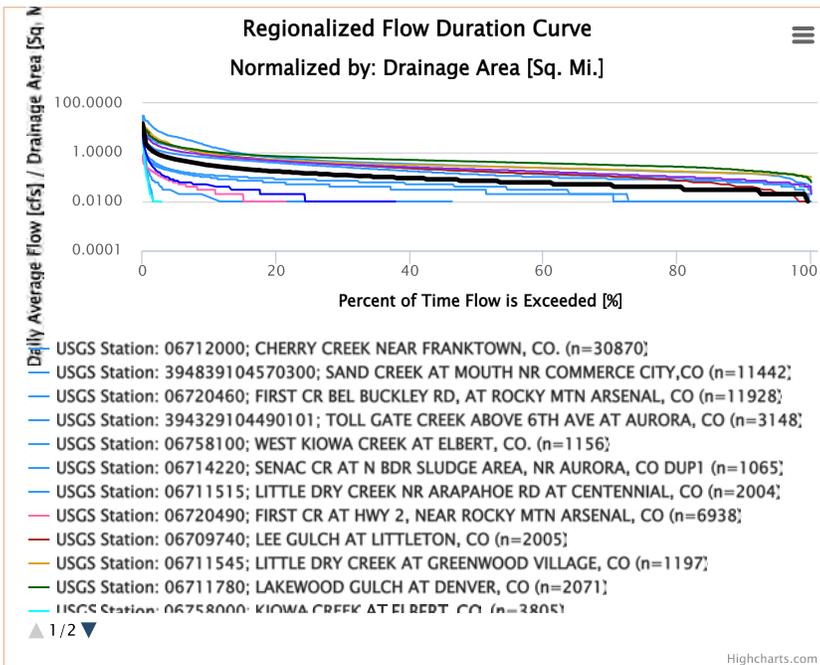
A regional flow duration curve (FDC) is an averaging of multiple FDCs from a number of gauges in a particular geographic region which exhibits similar traits (climate, geology, etc.). There are a number of ways to regionalize a flow duration curve given gauge data (statistical regression, parametric fitting, or graphical methods (Castellari et al., 2004)). The method used here is a graphical method similar to that used by Smakhtin et al. (2000) in which each individual gauge's flow duration curve is normalized based on a metric like drainage area, long-term average flow, or another flow metric like Q2 or bankfull discharge. The normalized flow duration curves are then averaged together (using their period length as a weighting factor as described by Niadas (2005)) to determine a regionalized FDC. Then for an ungauged basin in the geographic region, if the normalizing metric is estimated it can be combined with the regional FDC for an estimate of the FDC at the ungauged site.

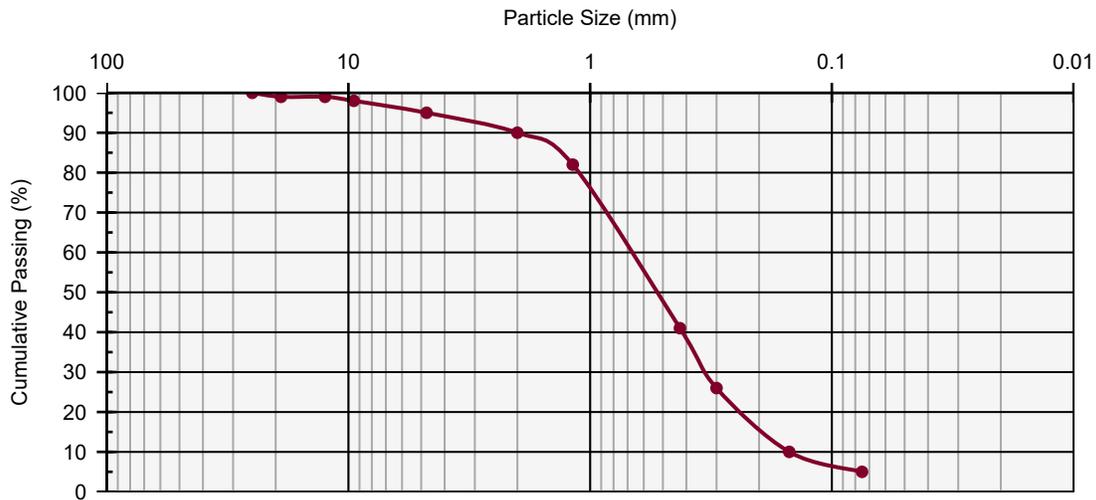
### Soil Gradation (ASTM D6913)

Method	Liquid Limit		Plastic Limit		Plasticity Index		Classification	
	Value	Spec.	Value	Spec.	Value	Spec.	USCS	AASHTO
Single Point	-	-	NP	-	NP	-	SP-SM	A-1-b (0)

Coarse Gradation				Fine Gradation			
Sieve Size	Particle Size (mm)	Cumulative Passing (%)	Specified (%)	Sieve Size	Particle Size (mm)	Cumulative Passing (%)	Specified (%)
6 in	150	-	-	No. 4	4.75	95	-
5 in	125	-	-	No. 8	2.36	-	-
4 in	100	-	-	No. 10	2.00	90	-
3 in	75	-	-	No. 16	1.18	82	-
2.5 in	63	-	-	No. 20	0.85	-	-
2 in	50	-	-	No. 30	0.60	-	-
1.5 in	37.5	-	-	No. 40	0.425	41	-
1 in	25.0	100	-	No. 50	0.300	26	-
3/4 in	19.0	99	-	No. 60	0.250	-	-
1/2 in	12.5	99	-	No. 100	0.150	10	-
3/8 in	9.5	98	-	No. 140	0.090	-	-
No. 4	4.75	95	-	No. 200	0.075	5	-

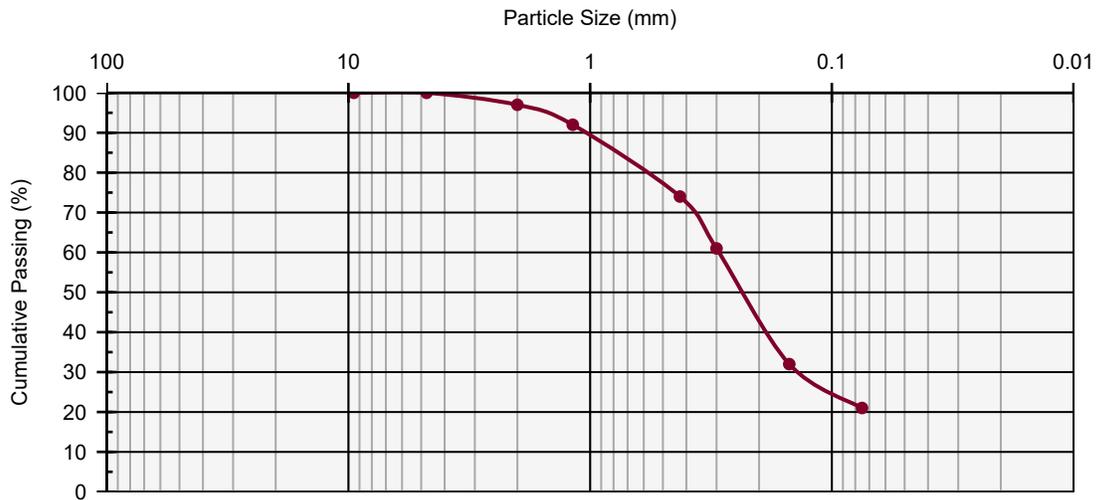
#### Soil Gradation (ASTM D6913)

Method	Liquid Limit		Plastic Limit		Plasticity Index		Classification	
	Value	Spec.	Value	Spec.	Value	Spec.	USCS	AASHTO
Single Point	31	-	23	-	8	-	SC	A-2-4 (0)

Coarse Gradation				Fine Gradation			
Sieve Size	Particle Size (mm)	Cumulative Passing (%)	Specified (%)	Sieve Size	Particle Size (mm)	Cumulative Passing (%)	Specified (%)
6 in	150	-	-	No. 4	4.75	100	-
5 in	125	-	-	No. 8	2.36	-	-
4 in	100	-	-	No. 10	2.00	97	-
3 in	75	-	-	No. 16	1.18	92	-
2.5 in	63	-	-	No. 20	0.85	-	-
2 in	50	-	-	No. 30	0.60	-	-
1.5 in	37.5	-	-	No. 40	0.425	74	-
1 in	25.0	-	-	No. 50	0.300	61	-
3/4 in	19.0	-	-	No. 60	0.250	-	-
1/2 in	12.5	-	-	No. 100	0.150	32	-
3/8 in	9.5	100	-	No. 140	0.090	-	-
No. 4	4.75	100	-	No. 200	0.075	21	-

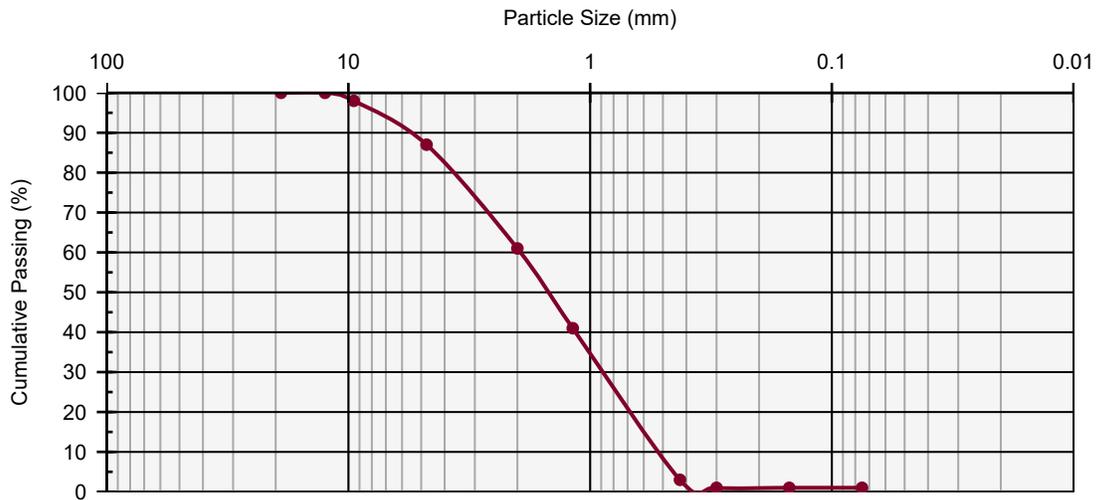
### Soil Gradation (ASTM D6913)

Method	Liquid Limit		Plastic Limit		Plasticity Index		Classification	
	Value	Spec.	Value	Spec.	Value	Spec.	USCS	AASHTO
Single Point	-	-	NP	-	NP	-	SP	A-1-b (0)

Coarse Gradation				Fine Gradation			
Sieve Size	Particle Size (mm)	Cumulative Passing (%)	Specified (%)	Sieve Size	Particle Size (mm)	Cumulative Passing (%)	Specified (%)
6 in	150	-	-	No. 4	4.75	87	-
5 in	125	-	-	No. 8	2.36	-	-
4 in	100	-	-	No. 10	2.00	61	-
3 in	75	-	-	No. 16	1.18	41	-
2.5 in	63	-	-	No. 20	0.85	-	-
2 in	50	-	-	No. 30	0.60	-	-
1.5 in	37.5	-	-	No. 40	0.425	3	-
1 in	25.0	-	-	No. 50	0.300	1	-
3/4 in	19.0	100	-	No. 60	0.250	-	-
1/2 in	12.5	100	-	No. 100	0.150	1	-
3/8 in	9.5	98	-	No. 140	0.090	-	-
No. 4	4.75	87	-	No. 200	0.075	1	-

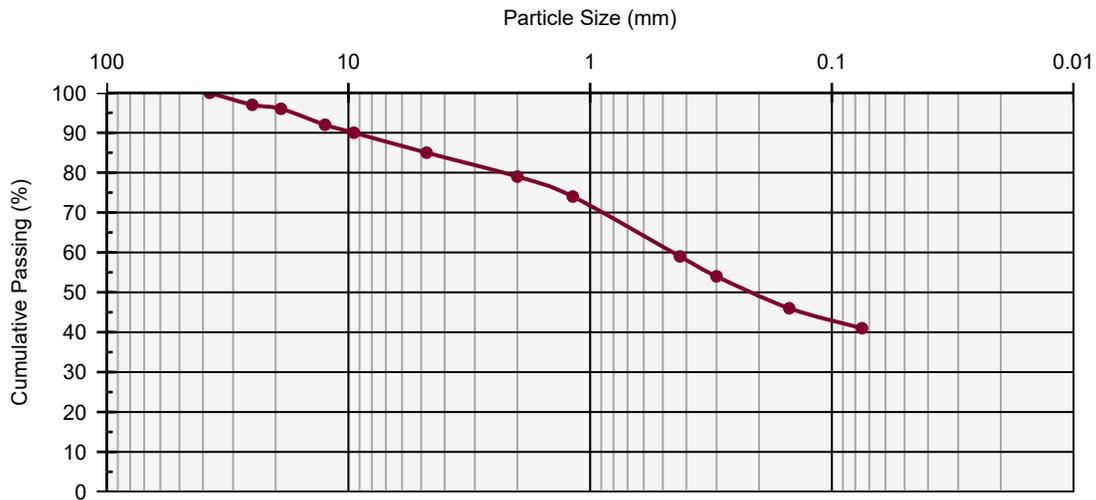
### Soil Gradation (ASTM D6913)

Method	Liquid Limit		Plastic Limit		Plasticity Index		Classification	
	Value	Spec.	Value	Spec.	Value	Spec.	USCS	AASHTO
Single Point	31	-	22	-	9	-	(SC)g	A-4 (1)

Coarse Gradation				Fine Gradation			
Sieve Size	Particle Size (mm)	Cumulative Passing (%)	Specified (%)	Sieve Size	Particle Size (mm)	Cumulative Passing (%)	Specified (%)
6 in	150	-	-	No. 4	4.75	85	-
5 in	125	-	-	No. 8	2.36	-	-
4 in	100	-	-	No. 10	2.00	79	-
3 in	75	-	-	No. 16	1.18	74	-
2.5 in	63	-	-	No. 20	0.85	-	-
2 in	50	-	-	No. 30	0.60	-	-
1.5 in	37.5	100	-	No. 40	0.425	59	-
1 in	25.0	97	-	No. 50	0.300	54	-
3/4 in	19.0	96	-	No. 60	0.250	-	-
1/2 in	12.5	92	-	No. 100	0.150	46	-
3/8 in	9.5	90	-	No. 140	0.090	-	-
No. 4	4.75	85	-	No. 200	0.075	41	-

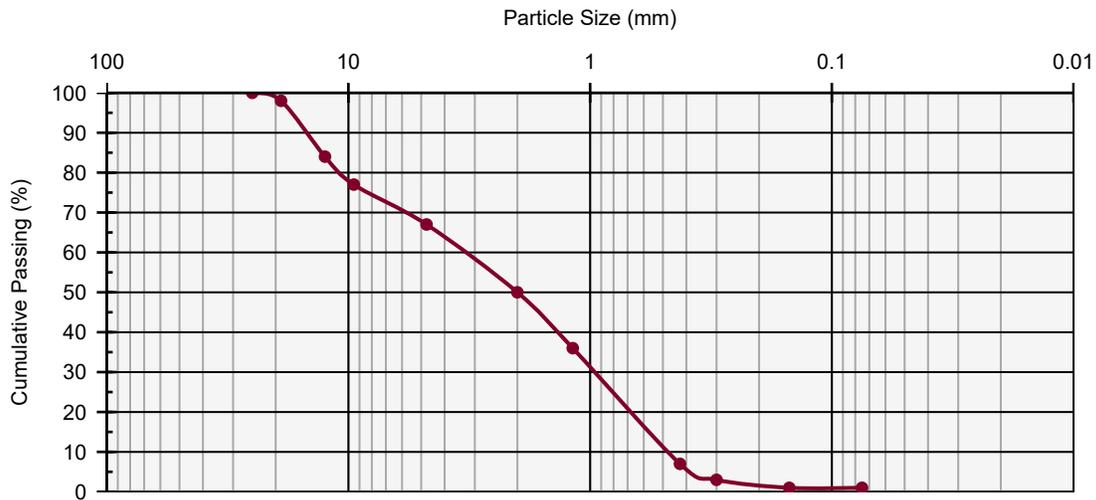
### Soil Gradation (ASTM D6913)

Method	Liquid Limit		Plastic Limit		Plasticity Index		Classification	
	Value	Spec.	Value	Spec.	Value	Spec.	USCS	AASHTO
Single Point	-	-	NP	-	NP	-	(SP)g	A-1-a (0)

Coarse Gradation				Fine Gradation			
Sieve Size	Particle Size (mm)	Cumulative Passing (%)	Specified (%)	Sieve Size	Particle Size (mm)	Cumulative Passing (%)	Specified (%)
6 in	150	-	-	No. 4	4.75	67	-
5 in	125	-	-	No. 8	2.36	-	-
4 in	100	-	-	No. 10	2.00	50	-
3 in	75	-	-	No. 16	1.18	36	-
2.5 in	63	-	-	No. 20	0.85	-	-
2 in	50	-	-	No. 30	0.60	-	-
1.5 in	37.5	-	-	No. 40	0.425	7	-
1 in	25.0	100	-	No. 50	0.300	3	-
3/4 in	19.0	98	-	No. 60	0.250	-	-
1/2 in	12.5	84	-	No. 100	0.150	1	-
3/8 in	9.5	77	-	No. 140	0.090	-	-
No. 4	4.75	67	-	No. 200	0.075	1	-

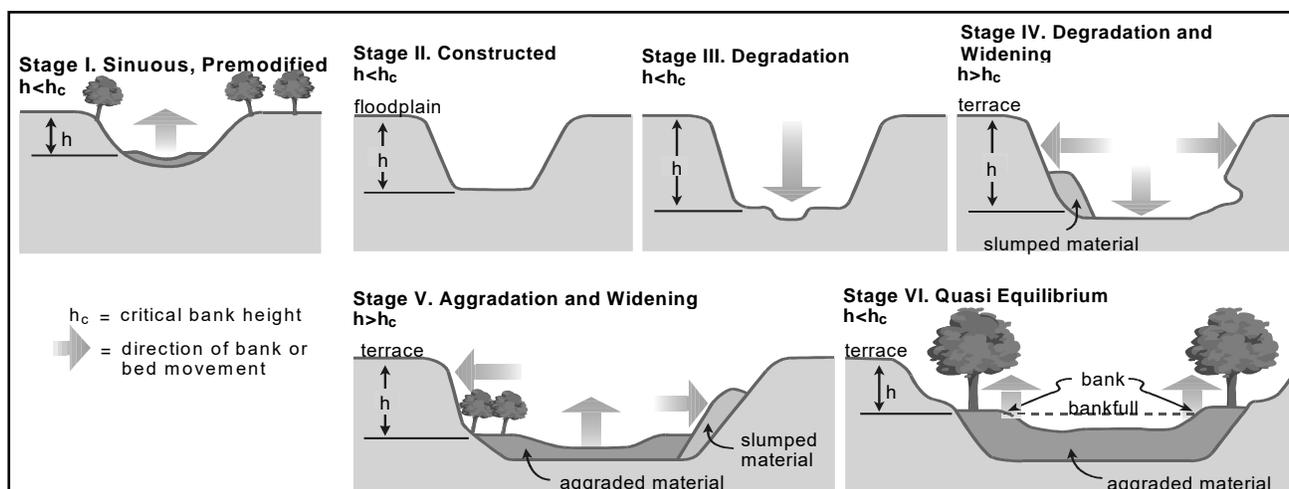
The channel evolution framework set out by Simon and Hupp (1986) is used by TMDL practitioners to assess the stability of a channel reach (Figure 12; Table 5). With stages of channel evolution tied to discrete channel processes and not strictly to specific channel shapes, they have been successfully used to describe systematic channel-adjustment processes over time and space in diverse environments, subject to various disturbances such as stream response to: channelization in the Southeast US Coastal Plain (Simon, 1994); volcanic eruptions in the Cascade Mountains (Simon, 1999); and dams in Tuscany, Italy (Rinaldi and Simon, 1998). Because the stages of channel evolution represent shifts in dominant channel processes, they are systematically related to suspended-sediment and bed-material discharge (Simon, 1989b; Kuhnle and Simon, 2000), fish-community structure, rates of channel widening (Simon and Hupp, 1992), and the density and distribution of woody-riparian vegetation (Hupp, 1992).

**Figure 12 – Six stages of channel evolution from Simon and Hupp (1986) and Simon (1989a) identifying Stages I and VI as ‘reference’ channel conditions (See Table 5 for explanation of stages).**
